TECHNICAL SERVICE BULLETIN

5.0L - Oil Leaks From Valve Cover Gasket

19-2260
28 August 2019

Ford 2015-2017 Mustang

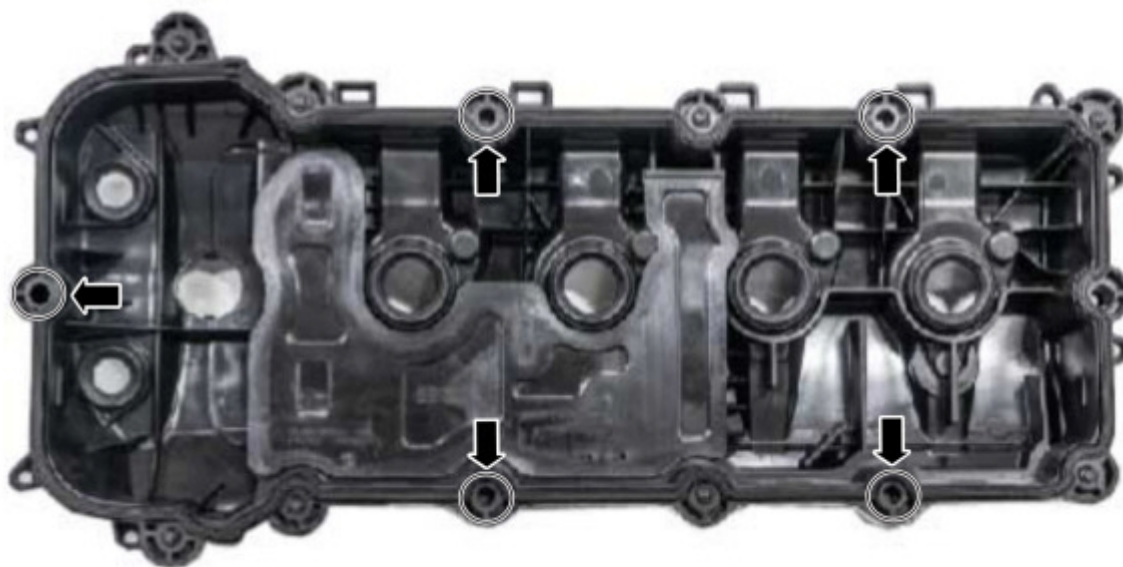
Figure 1

Issue: Some 2015-2017 Mustang vehicles equipped with a 5.0L engine may exhibit an oil leak from either valve cover gasket. This may be due to the number of fasteners used to hold the valve cover onto the cylinder head. To correct the condition, follow the Service Procedure steps to add fasteners to both valve covers.

CAUTION: Use a shop rag to prevent shavings from the drilling process from going into the under side of the valve cover. Thoroughly clean the under side of each valve cover after drilling to remove any shavings which may have entered into the under side of the valve cover. Any shavings left in the valve cover when it is reinstalled on the engine may enter the engine and cause damage to it.

2. Using a 10 mm (0.394 in) drill bit and drilling from the underside of the valve covers, drill holes through the 5 tabs along the perimeter of the valve covers that do not already have holes. This will allow fasteners to go through them. Use the indented area on each tab as a guide to center the drill bit to make sure the holes are drilled in proper alignment to allow fasteners to pass through them and thread into the corresponding holes in the cylinder head when the valve covers are reinstalled on the engine. (Figure 1, right side shown, left side similar)
