## GENERAL SERVICE BULLETIN

### Gas Engine Performance Modifications

**20-7094**

17 September 2020

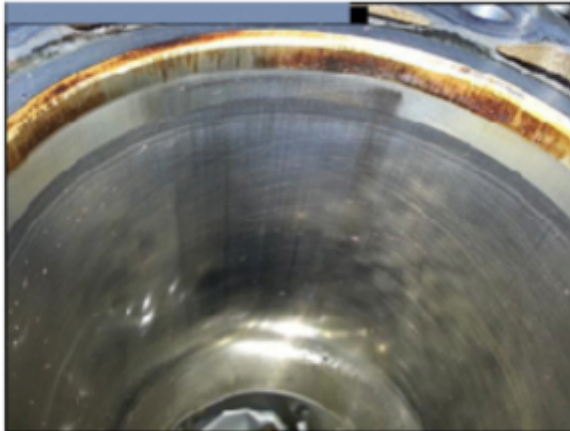
Figure 1

Scored cylinder wall. (Figure 1)

**Description:** Damage to piston profiles can often be attributed to pre-ignition (knock) events. OEM calibrations will protect the engine from pre-ignition damage by retarding spark. Aftermarket calibrations will typically change timing schedules and allow the engine to run closer to damage limits. Pre-ignition along with extreme air-fuel ratios and excessive oil consumption may also damage catalyst material. This material can then be pulled back into the engine, scoring the cylinder bore walls.

- Aftermarket calibration
- Turbo modifications
- Exhaust system modifications
- Catalyst damage
- Low quality fuel

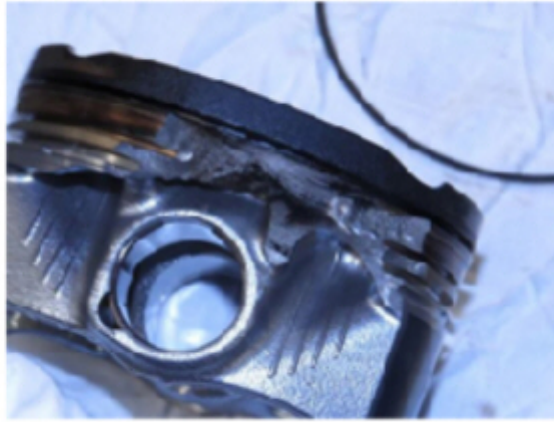
Figure 2

Piston ring land damage. (Figure 2)

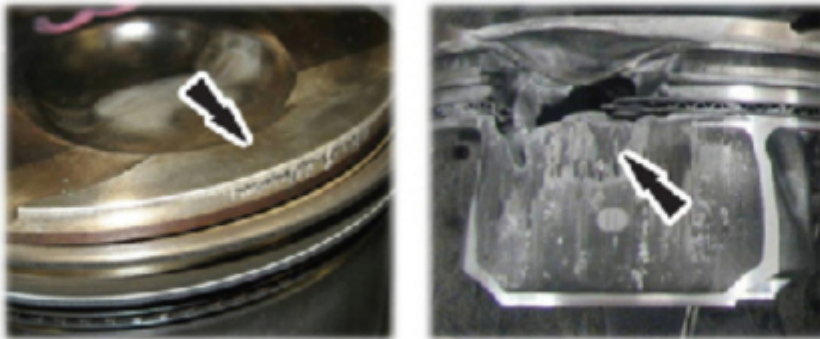
Figure 3

Piston damage from pre-ignition. (Figure 3)

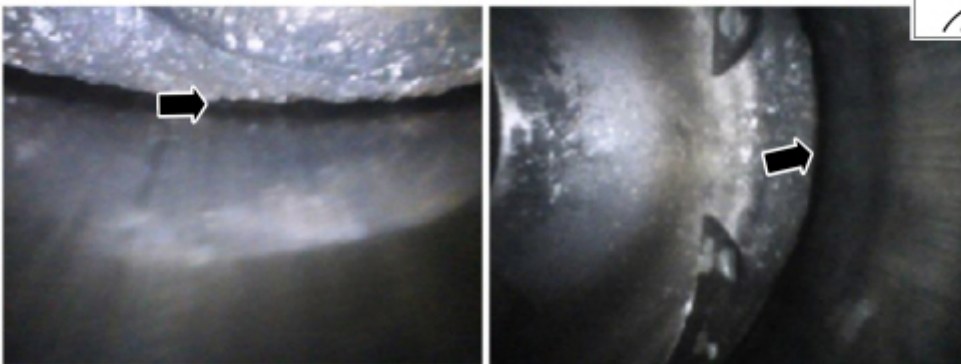
Figure 4

Borescope view of piston damage and cylinder scoring. (Figure 4)

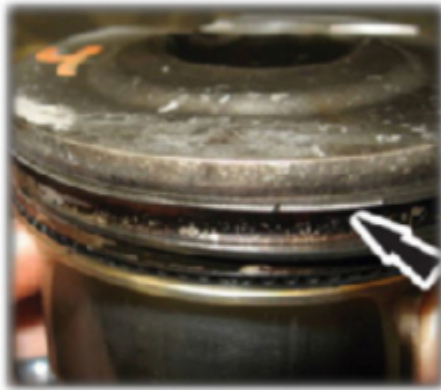
Figure 5

Piston ring damage. (Figure 5)

**Description:** Similar to the pre-ignition piston damage, piston rings can also be damaged from preignition (knock) events. OEM calibrations will protect the engine from pre-ignition damage by retarding spark. Aftermarket calibrations will typically change timing schedules and allow the engine to run closer to damage limits. Damage to the top piston ring may exhibit in the form of delamination, pitting or fracture.

- Excessive spark advance from aftermarket calibration
- Excessive spark advance from changes in induction system

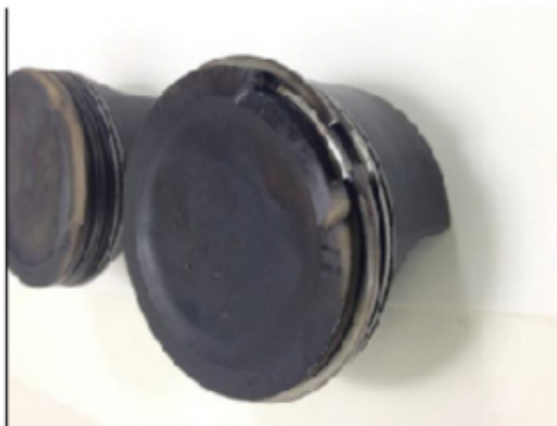
Figure 6

Ring land damage. (Figure 6)

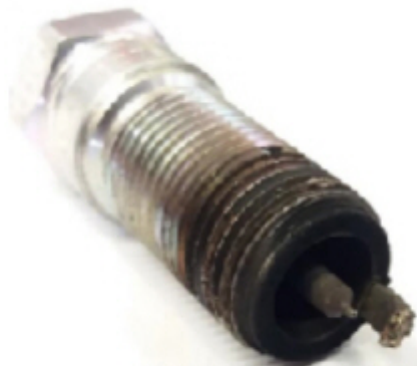
Figure 7

Spark plug ground electrode damage. (Figure 7)

Spark plug damage as shown in the figures above can be another indicator of an aftermarket calibration, changes to the vehicle induction system, or other revisions that can increase combustion temperatures. This is especially true when the plugs show rapid degradation in all cylinders as shown in Figure 8.

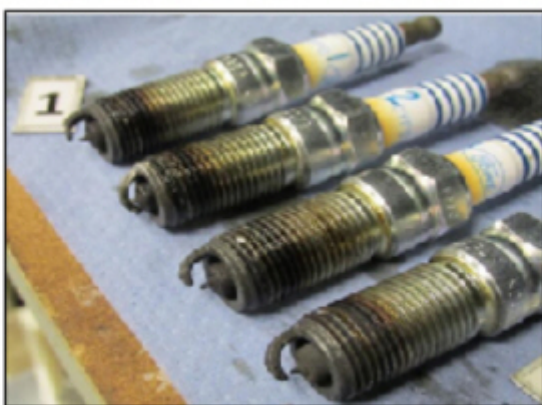
Figure 8

Spark plug damage and abnormal color. (Figure 8)

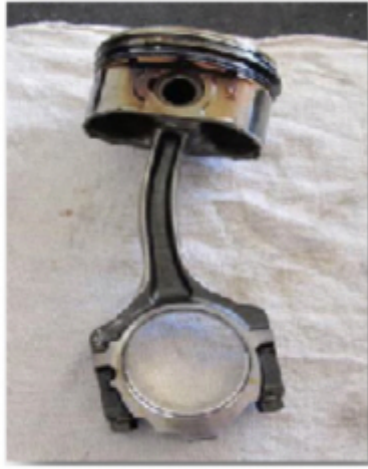
Figure 9

Bent connecting rod from hydrolock. (Figure 9)

**Description:** Hydrolock occurs when a volume of liquid greater than the smallest volume of the combustion chamber enters the cylinder and becomes incompressible as the piston reaches Top Dead Center. The result is most commonly a bent or broken connecting rod. Connecting rod damage may also be caused by excessive cylinder pressure (overboost condition) and may not be obvious via visual inspection. Connecting rod twisting can lead to bore scoring and eventual piston failure. Note that connecting rod bends or twists may not be obvious visually, but can still contribute to engine damage or failure.

- Leaking fuel injectors
- Rerouted air induction systems that show evidence of water ingestion
- Turbocharger modifications
- Supercharger modifications

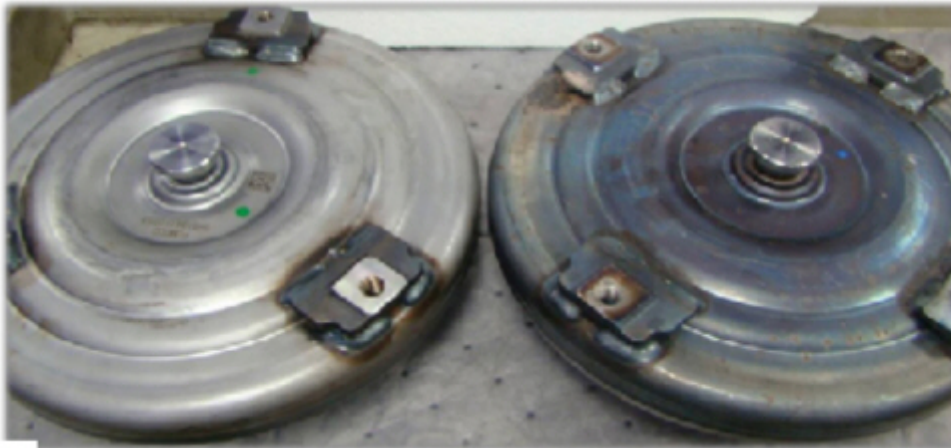
Figure 10

Normal converter on the left, overheated converter on the right. (Figure 10)

**Description:** Overheated torque converters will exhibit discoloration.

- Any aftermarket modification that increases torque or power output may cause the torque converter to overheat.

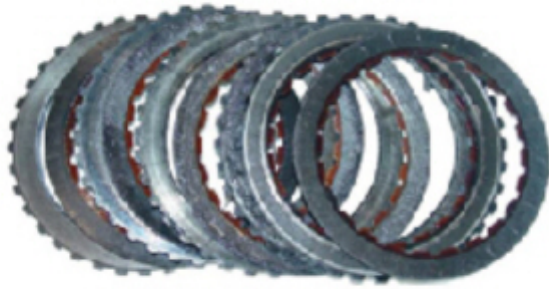
Figure 11

Damaged clutch discs. (Figures 11-12)

**Description:** Clutch damage can present itself in many forms including discoloration, cracking, and warping of the clutch discs and separator plates.

- Any aftermarket modification that increases torque or power output may cause damage to the clutch system

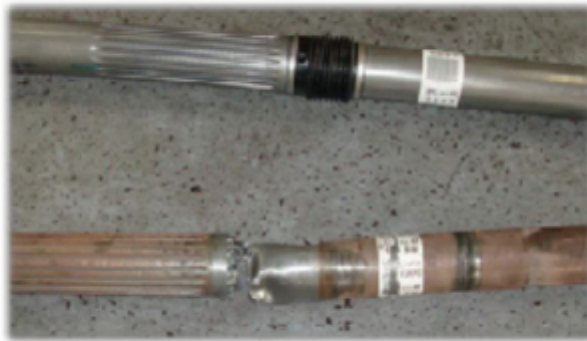
Figure 13

Twisted driveshaft. (Figures 13-14)

**Description:** Twisting of the driveshaft is commonly associated with increased torque output.

- Any aftermarket modification that increases torque or power output may cause damage to the driveshaft.
- Soft compound race tires (often identified by rubber built up in the wheel well) combined with hard launches.

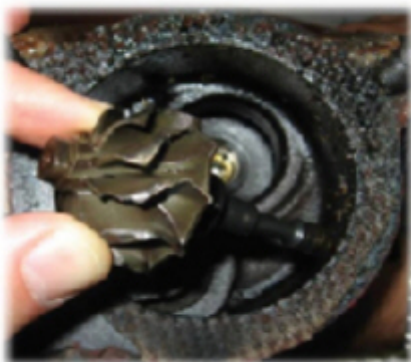
Figure 15

Compressor blade damage from overspeed. (Figures 15-16)

**Description:** Turbo compressor damage is commonly identified by broken or deformed turbine blades.

- Aftermarket calibration
- Wastegate modification
- Exhaust system modification
- Air induction system modification
  - Cold air intake
  - Throttle body spacer
- Aftermarket blow off valve

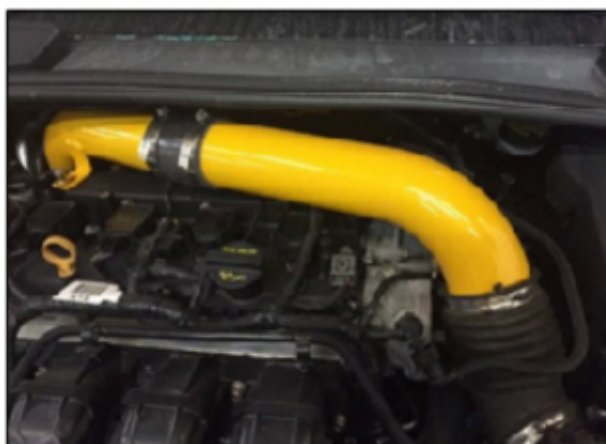
Figure 17

Aftermarket intake tube. (Figure 17)

**Description:** Modifications to the air intake system may include aftermarket air boxes, filters and low/high pressure air ducts. The system may be particularly susceptible to flexible air ducts between the air filter and the compressors. Restrictions on either side of the compressor can result in over-speeding the turbo in forced induction engines. Aftermarket air induction systems may cause lean air/fuel ratio DTCs (P0171 and P0174).

- Turbocharger compressor damage
- Catalyst damage
- Piston damage from detonation

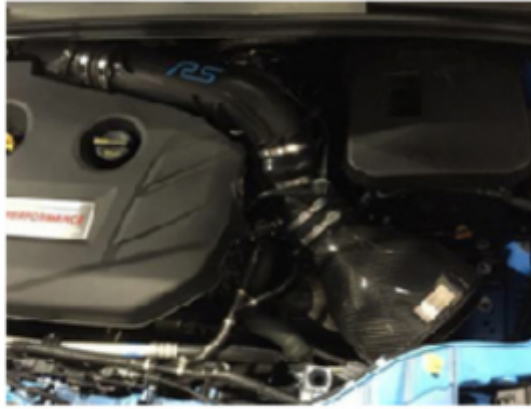
Figure 18

Aftermarket air filter assembly. (Figure 18)

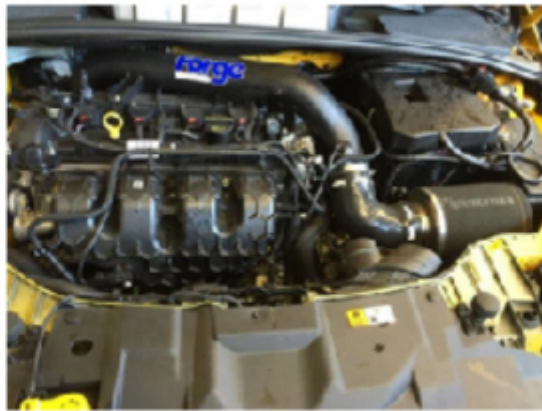
Figure 19

Aftermarket intake tube and air filter assembly. (Figure 19)

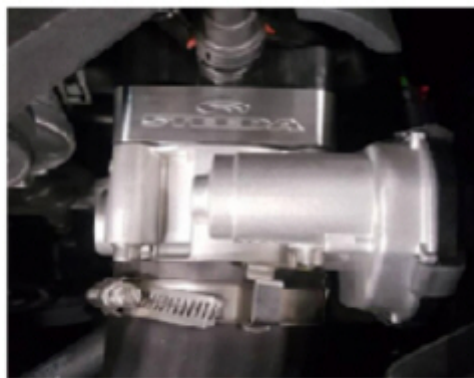
Figure 20

Aftermarket air induction pump. (Figure 20)

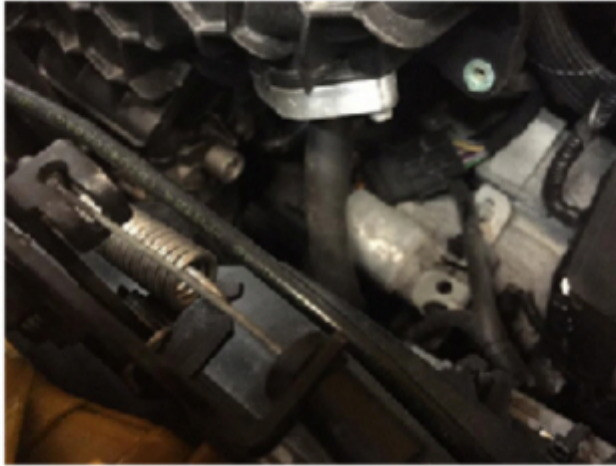
Figure 21

PVC block-off plate. (Figure 21)

**Description:** PCV systems that are modified (vented to atmosphere being the most common modification) can result in a condition where oil gets past the turbine seal even on an undamaged, fully functional turbocharger. Oil in the exhaust system alone may not be sufficient evidence to identify a failed turbo if the PCV system has been compromised. Modified PVC systems can also contribute to oil consumption and are often good indicators that other engine modifications are likely present.

- Unlikely to be the direct cause of base engine failure
- Emission compliance issue
- Oil in exhaust system and/or smoke from tailpipe
- Oil consumption concerns

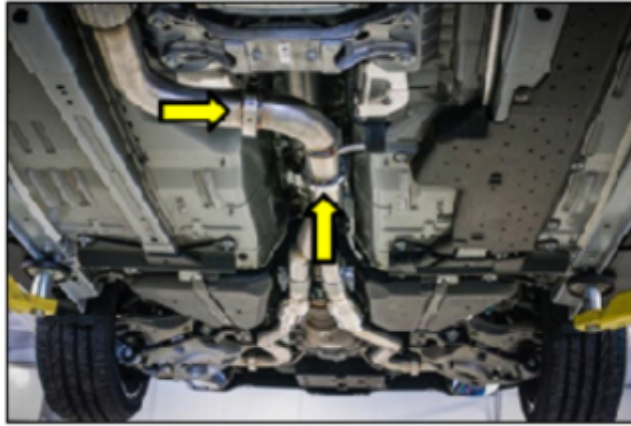
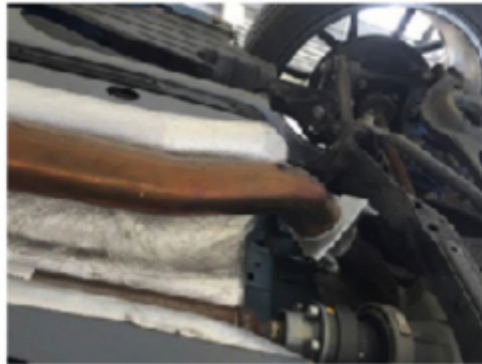
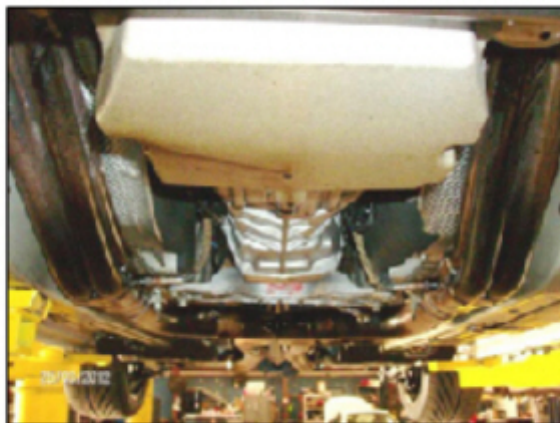
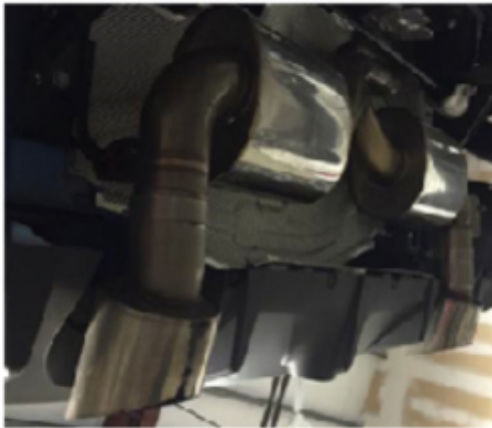
Aftermarket exhaust examples. (Figures 22-25)

**Description:** Common modifications include the removal of catalysts, mufflers and resonators. In turbocharged applications modifications to the exhaust system can reduce backpressure and may result in over-speeding the turbocharger(s). In some cases a good indicator of an aftermarket exhaust is the presence of additional clamps. Visually compare the installed exhaust to the pictures of OEM exhaust, if necessary.

- Turbocharger compressor damage
- Exhaust smoke due to change in system backpressure
- Piston damage

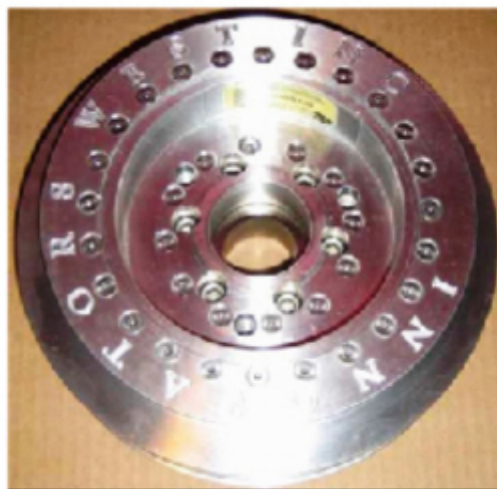
Figure 26

Aftermarket crankshaft pulley. (Figure 26)

**Description:** Overdrive pulleys are intended to spin faster than OEM pulleys. On forced induction engines they may increase boost pressure which can lead to an overboost condition and subsequent engine damage. Most aftermarket pulleys are machine finished, where OEM pulleys are painted a dull black. Examine the stock pulley bolt for signs of tampering.

- Piston damage
- Driveshaft damage
- Clutch damage
- Oil Pump damage

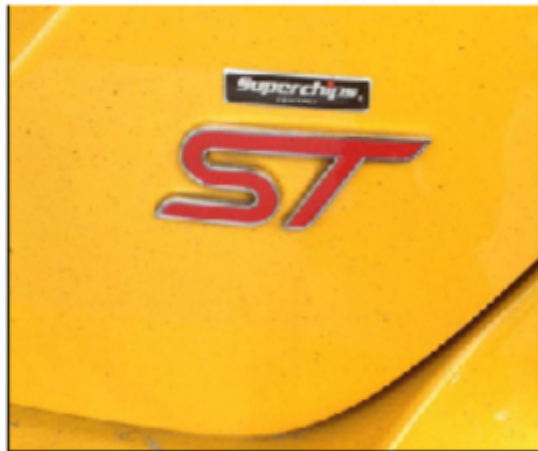
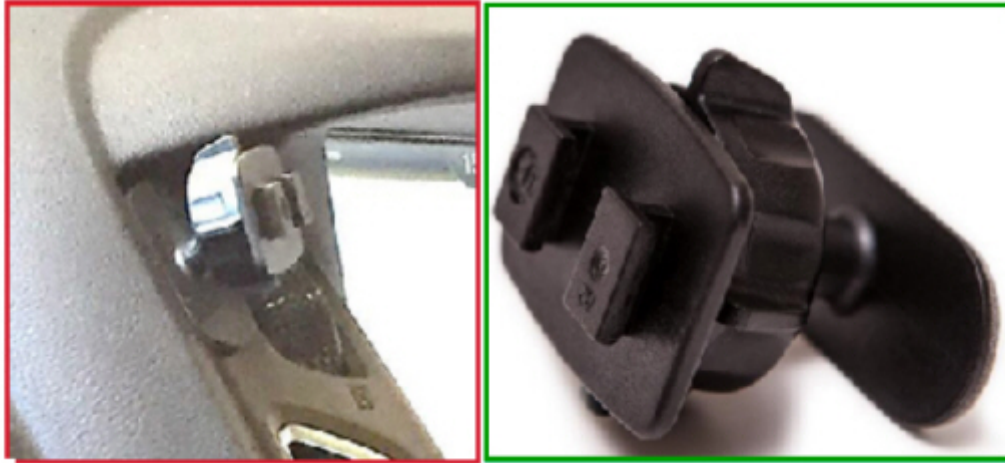
Figures 27-28

**Description:** Badges from aftermarket companies are indicators of possible aftermarket modifications present including calibrations. Dash and/or A-pillar mounts are also indicators of a possible aftermarket calibration. Inquire with the customer about the purpose of any badges and/or mounts and check for the existence of an aftermarket calibration.

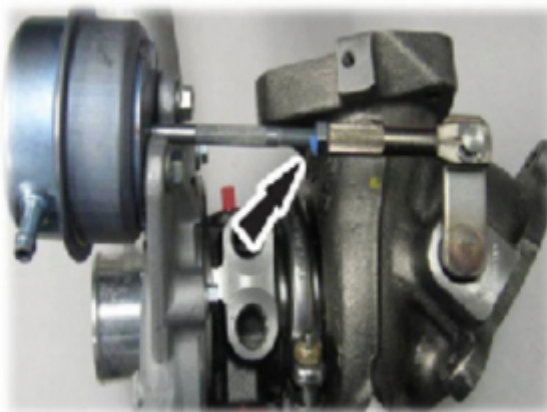
Figure 29

Wastegate adjuster modification. (Figure 29)

**Description:** The full load output of some turbocharged engines will increase if the wastegate spring pretension is increased. This is not the case with the EcoBoost engine. Adjusting the wastegate pre-tension out of the specified range can result in DTCs. A tamper evident paint dot has been applied to the wastegate actuator adjustment mechanism to make modifications more apparent.

- Piston damage
- Turbocharger damage

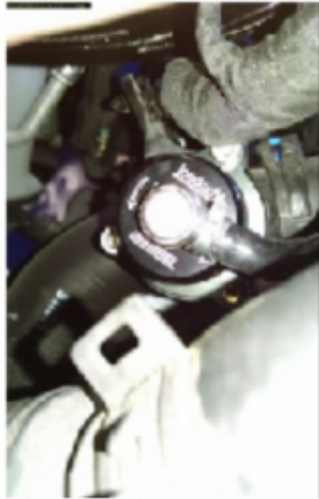
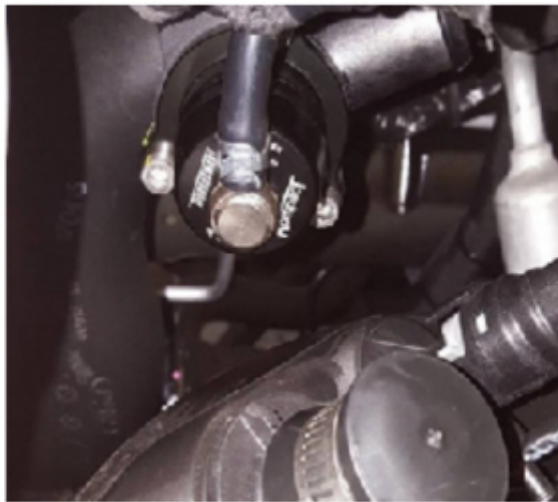
Figures 30-31

**Description:** Bypass valves relieve intake manifold pressure to prevent turbo compressor surge. When the pressure is released a distinct hissing sound can be heard. Bypass valves are often tuned for their auditory effect. In doing so, the amount of pressure relieved from the system can change leading to compressor surge.

- Turbocharger compressor damage

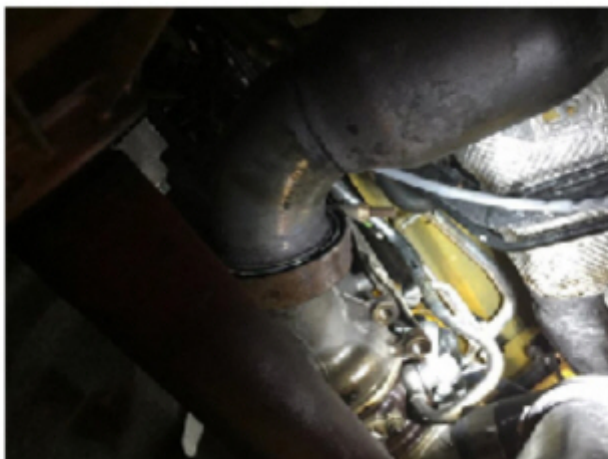
Figure 32

**Description:** A downpipe is an unrestricted section of exhaust directly downstream of the turbo. By unrestricted the flow, the turbo may be able to spool up faster, reducing turbo lag. However, unrestricted the flow of exhaust can change the backpressure in the system which can lead to turbo overspeed.

- Turbocharger Compressor Damage
- Piston damage
- Exhaust smoke from turbocharger seal leakage

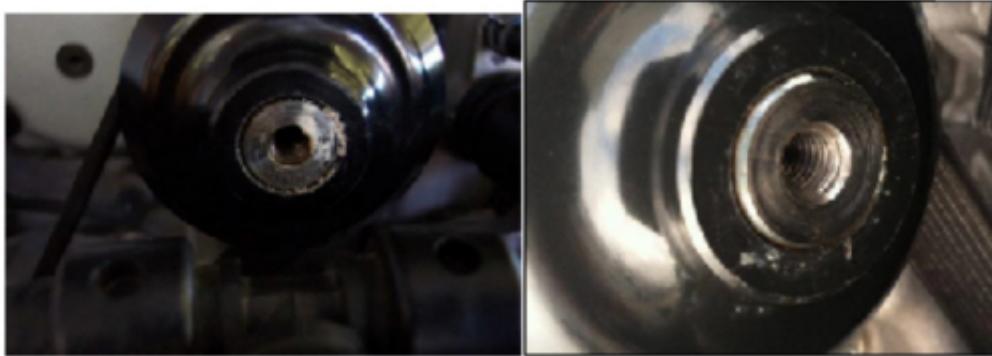
**Description:** Customers may modify or replace supercharger drive pulleys to increase supercharger speed and associated boost pressure. Customers may reinstall the OEM drive pulley before bringing the vehicle in for repair. Figure 33 shows both untampered and tampered with pulleys. On the left side of Figure 33, note the white anti-tamper compound and smooth face of the supercharger shaft. The black plastic cover is a Christmas tree style and can be removed by unscrewing it from the blower shaft. On the right side of Figure 33, note the white anti-tamper compound is almost all removed and is misaligned (12 o'clock on shaft and 3 o'clock on pulley). Gall marks on the face of the blower shaft and scuff marks on the face of the pulley indicate use of a puller to remove the pulley and a press tool to reinstall the pulley. The most common change is a smaller diameter drive pulley to increase boost by spinning the supercharger at higher RPMs. This modification also requires an aftermarket calibration. The OEM pulley diameters are 3.0 inches for the 5.4L and 2.7 inches for the 5.8L. Aftermarket pulleys are available in various sizes smaller than these diameters and may visually appear to look exactly like OEM stock pulleys.

- Piston damage
- Transmission clutch damage

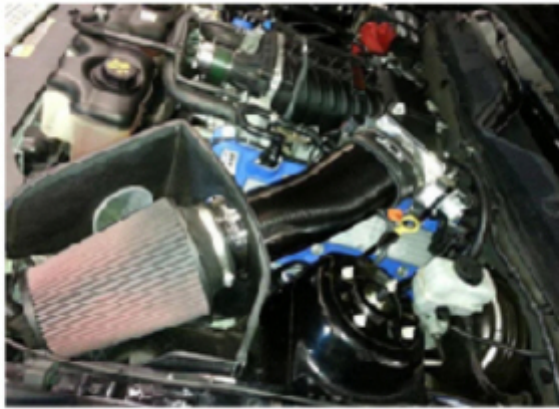
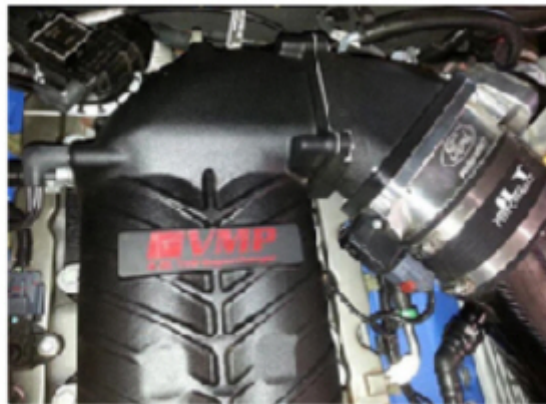
Aftermarket supercharger, throttle body and air induction tube. (Figures 34-35)

**Description:** Adding aftermarket superchargers can stress the engine beyond design limits through increased torque and power outputs and cause numerous failures. Changes in the induction system such as aftermarket throttle bodies and inlet tubes can cause changes in air-fuel ratio that leads to piston damage. These modifications should be easily visible. Most aftermarket superchargers will have a custom surface finish (polished or wrinkle black).

- Piston damage
- Transmission clutch damage
- Driveshaft damage
