General Service Bulletin (GSB):	Engine Failure Analysis and Tips
GSB Overview:	This bulletin provides tips to assist the dealership when performing engine diagnostics and root cause determination.
NOTE: This information is not intended to replace or supersede any warranty, parts and service policy, Work Shop Manual (WSM) procedures, PC/ED procedures or technical training or wiring diagram information.

# **Engine Failure Analysis and Tips Job Aid**

Guide to Engine Analysis and Preventing Repeat Engine Failures

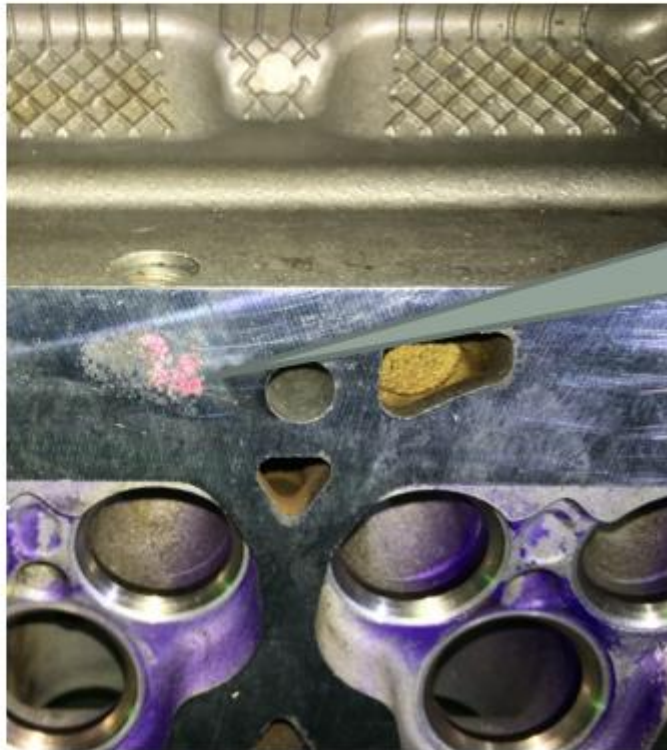
This will **NOT** cause engine noise or head gasket leaks—nowhere near a sealing bead!

If a vehicle comes in for service with an engine noise complaint, and a cosmetic variation is seen on the head surface during root cause analysis (with no coolant or oil consumption), this has **NO** relation to the complaint.

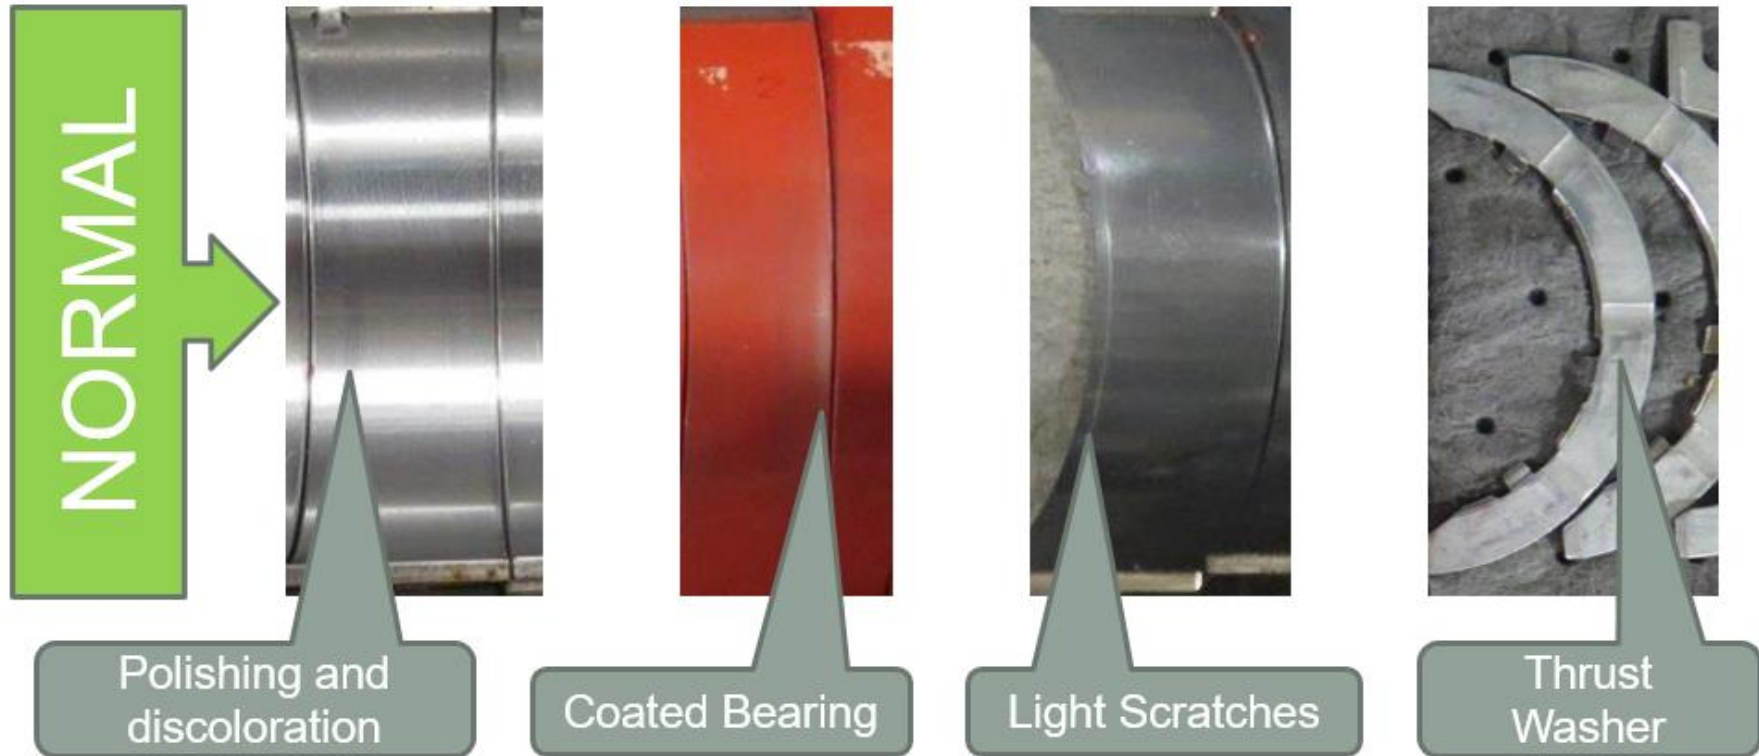
## Bearing--Acceptable Wear / Conditions

- Polishing
- Discoloration
- Light contact with the red coating
- Light scoring

NOTE. Bearings are designed to manage some debris; therefore, some light scoring found on the bearing surface is not necessarily an indication of engine failure or root cause determination.

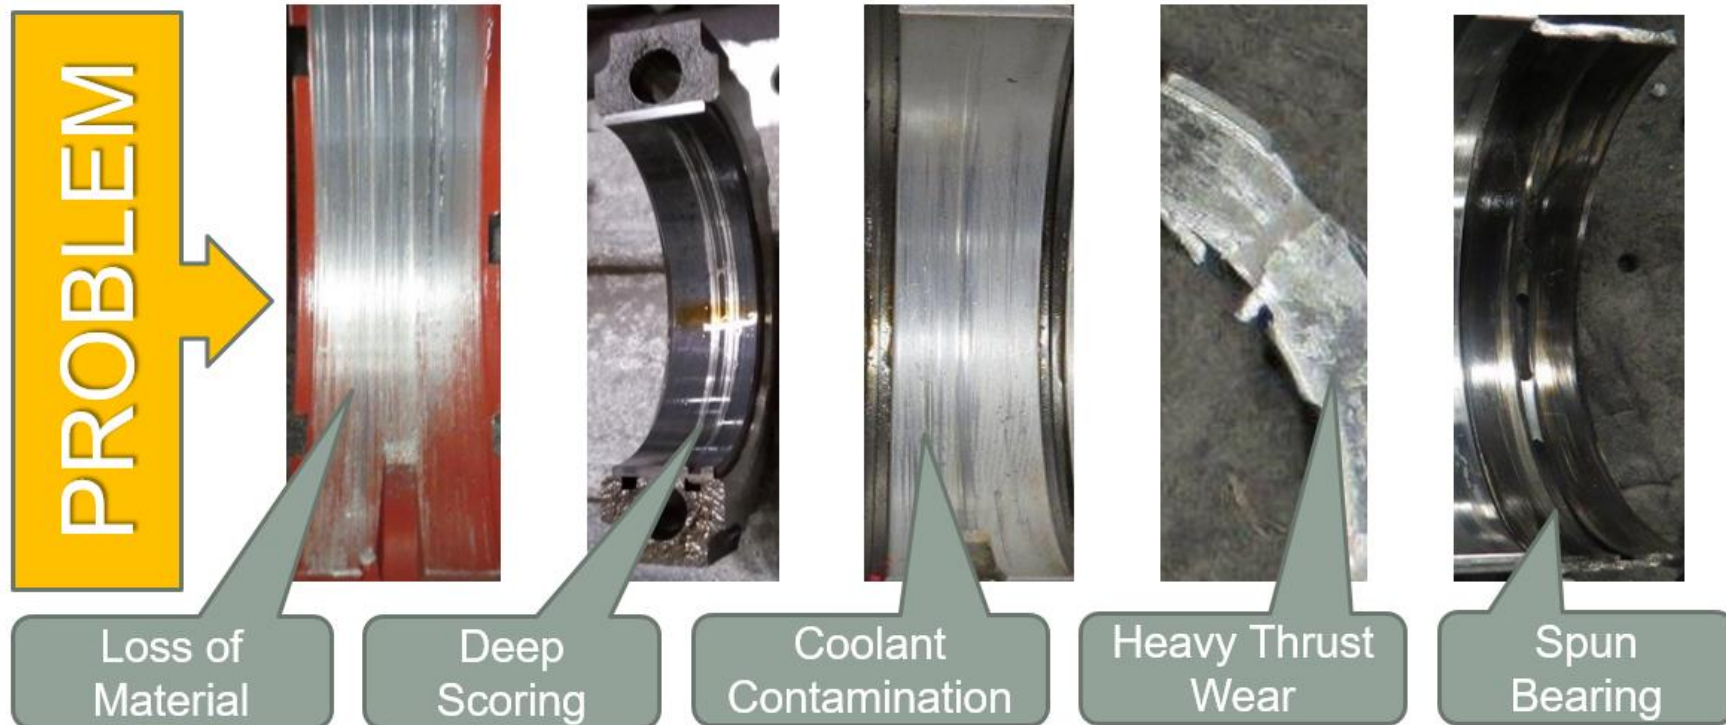
# Bearing—Unacceptable Wear

- Metal transfer
- Erosion
- Significant loss of material--excessive clearance
- Coolant contamination
- Deep scoring or Cracking
- Spun bearing

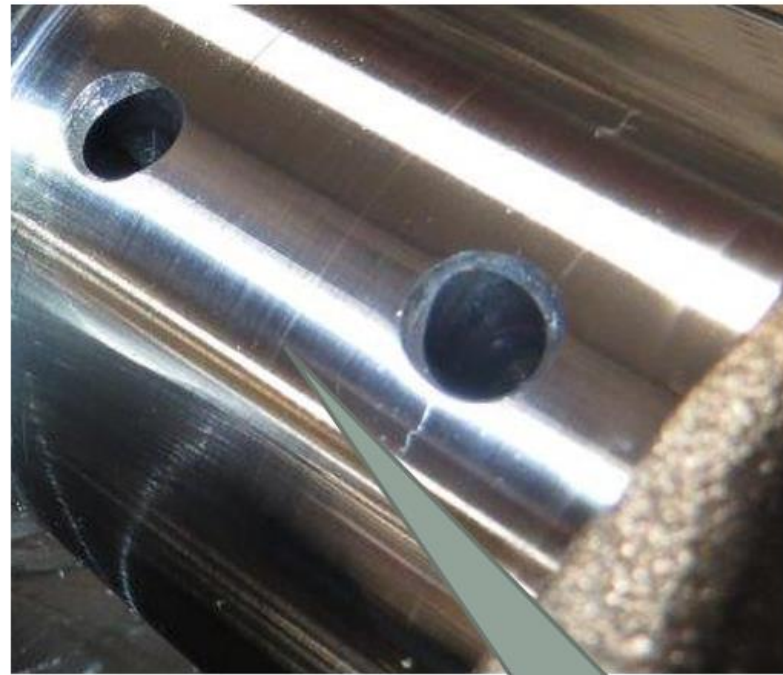
Discoloration and  
Polishing

No Loss of  
Material

Light Scratches

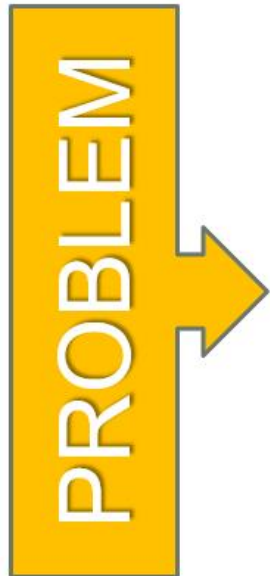
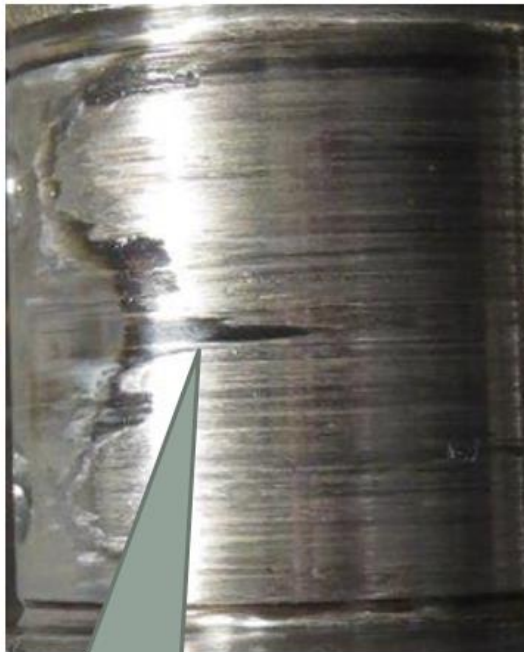
### Crankshaft—Unacceptable Wear

- Significant material loss
- Metal transfer
- Deep scratches
- Gouges
- Bluing: lack of proper lubrication
- Cracking

Significant  
Material Loss

Deep Scratches

Bearing Metal Transfer

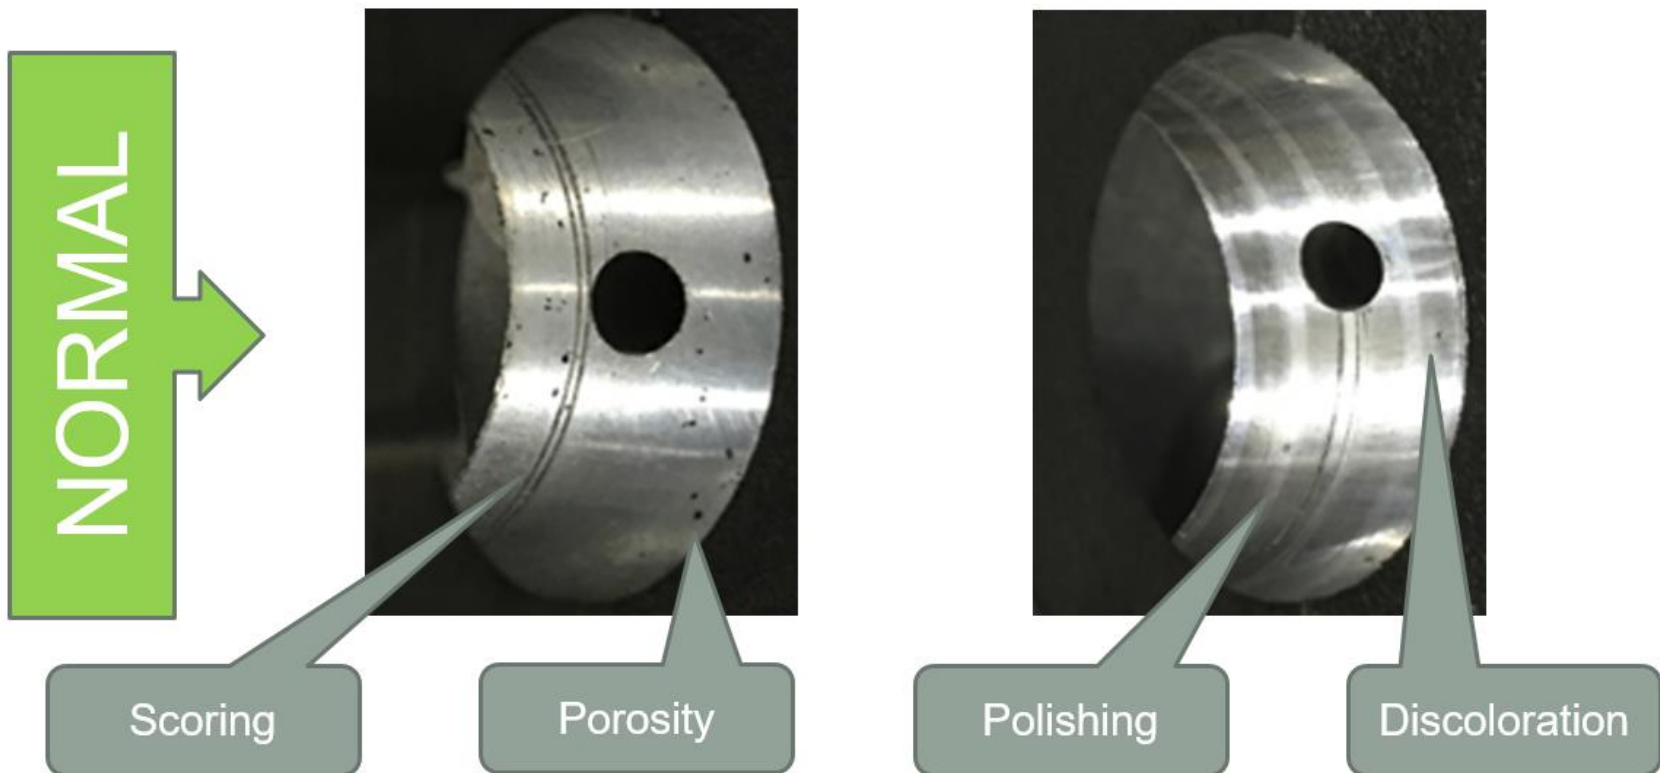
### Cam Bore—Acceptable Wear / Conditions

- Polishing
- Discoloration
- Some porosity
- Uniform or symmetrical score felt with a fingernail is OK—just holds more oil

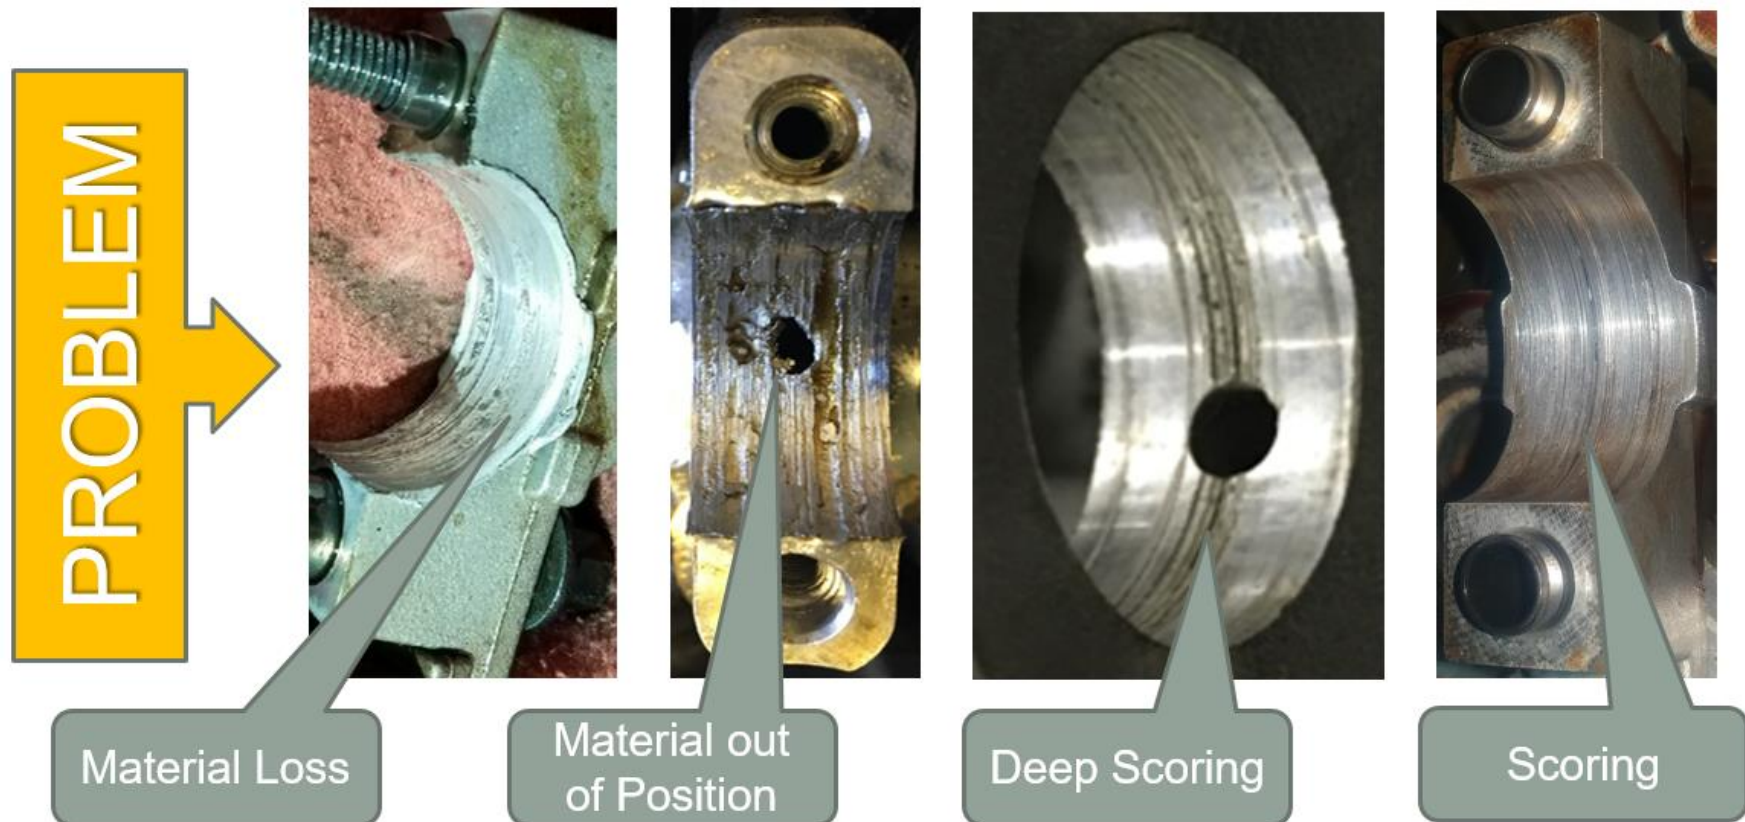
### Cam Bore—Unacceptable Wear

- Metal transfer or loss of material
- Material out of position
- Excessive Clearance
- Heavy Scoring

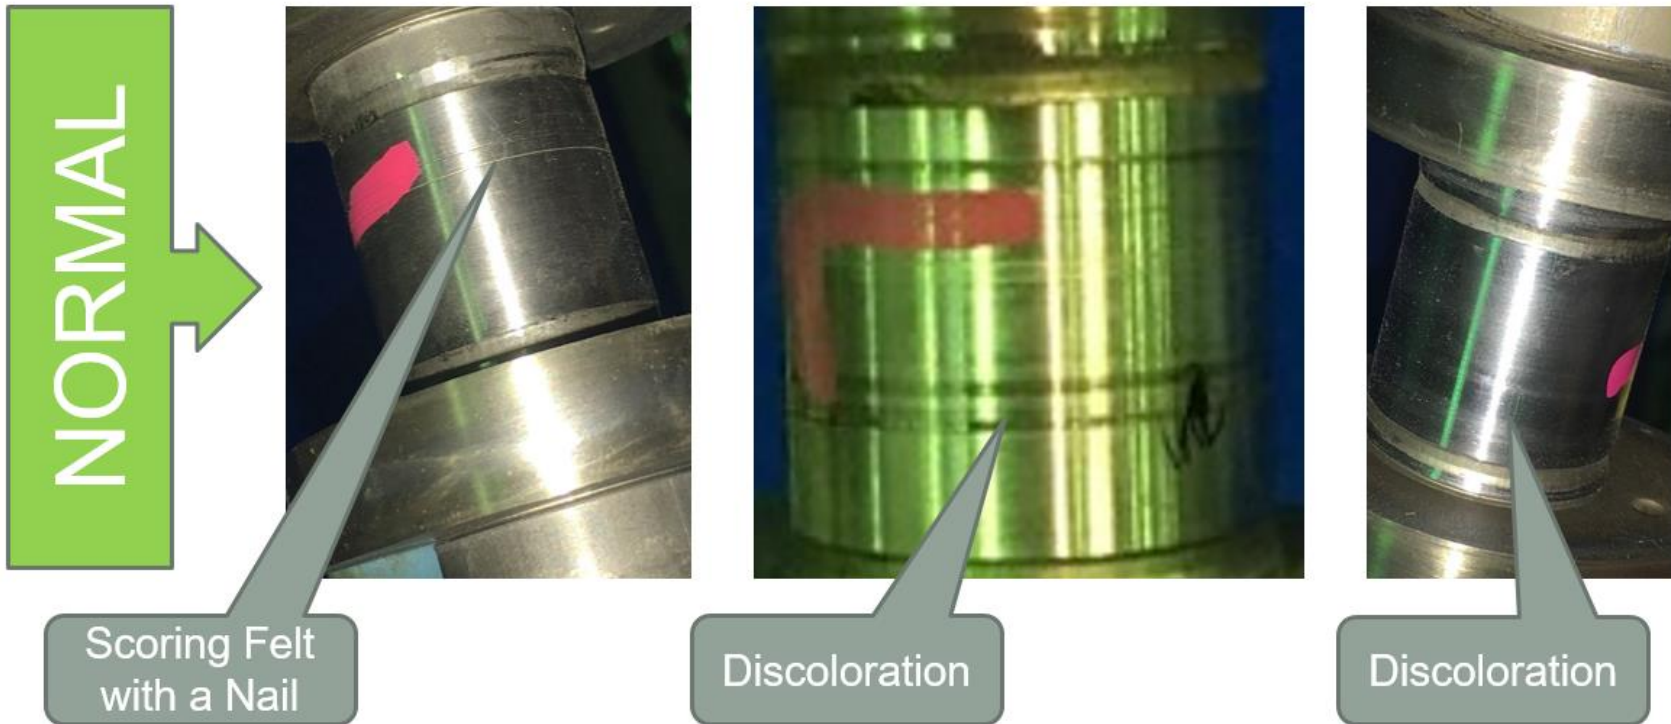
### Cam Journal—Acceptable Wear / Conditions

- Polishing
- Discoloration
- Uniform or symmetrical score felt with a fingernail is OK—just holds more oil

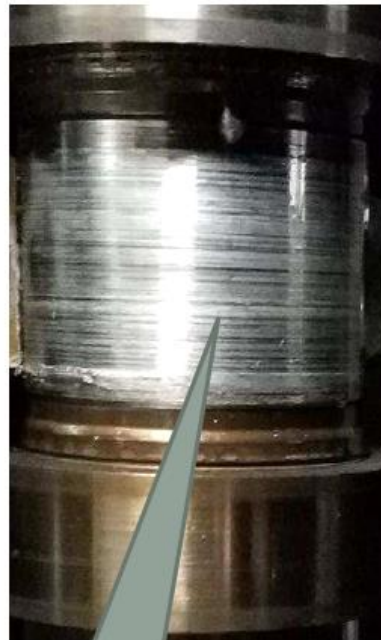
### Cam Journal—Unacceptable Wear

- Metal transfer or material loss—Excessive Clearance
- Deep scoring
- Bluing
- Cracking

Material Loss

Metal Transfer

Bluing

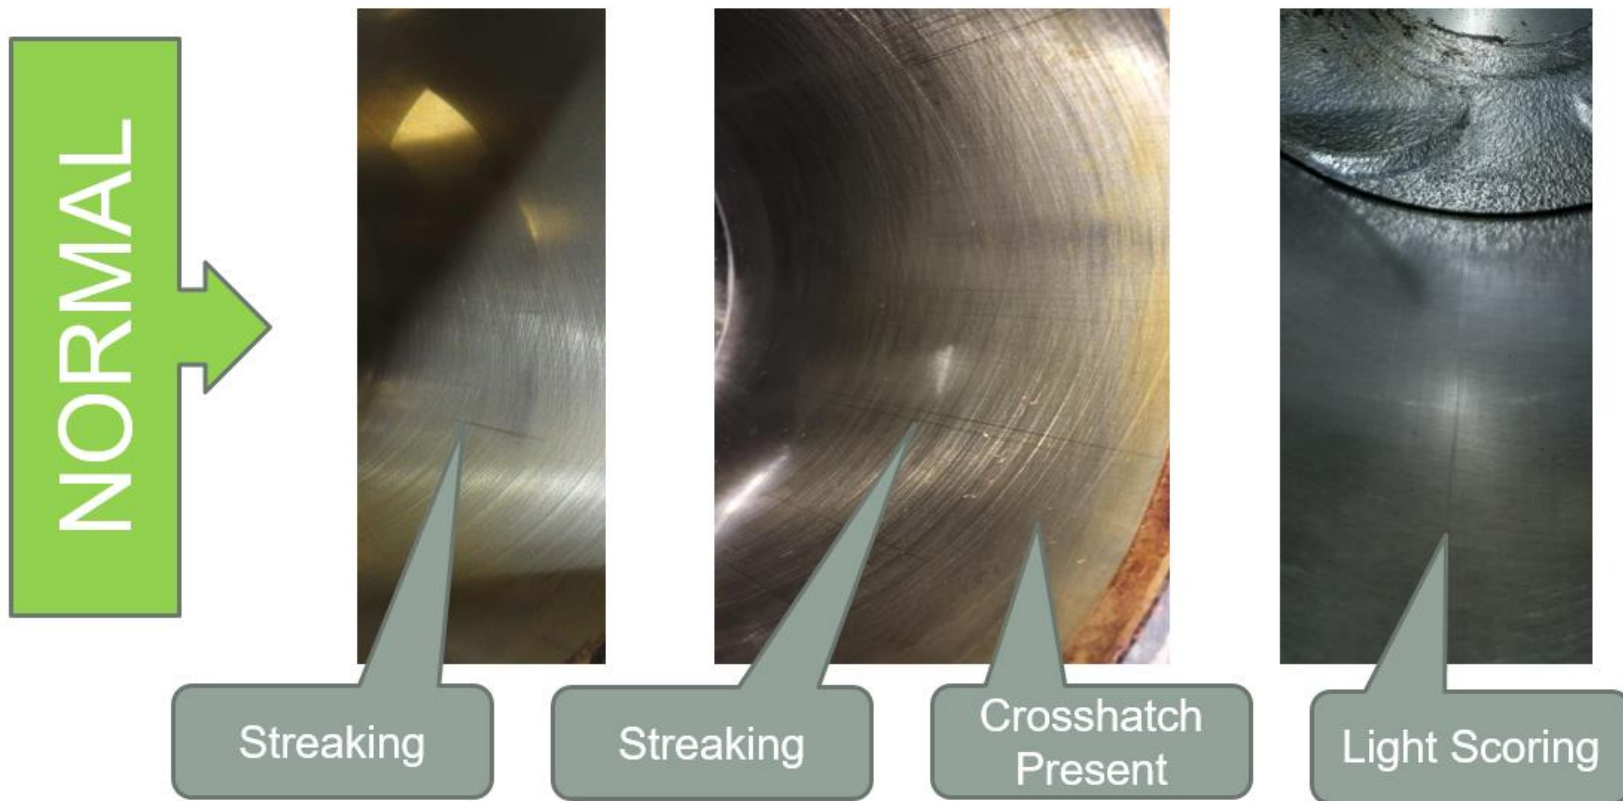
### Cylinder Wall-Acceptable Wear / Conditions

- Some polishing and discoloration
- Vertical streaking
- Some light scoring felt with a fingernail
- Cross hatch is visually present
- Light staining / spots
- Light piston slap contact

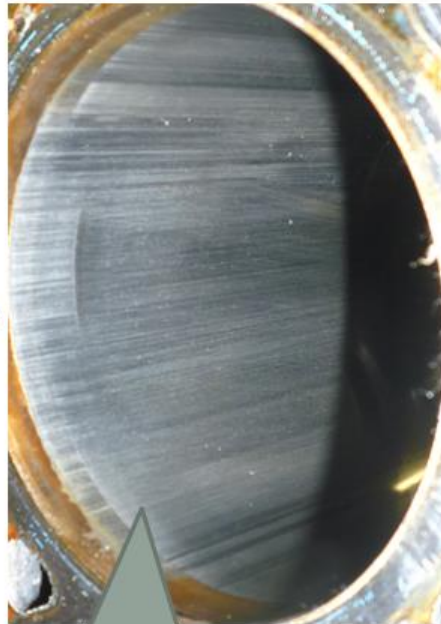
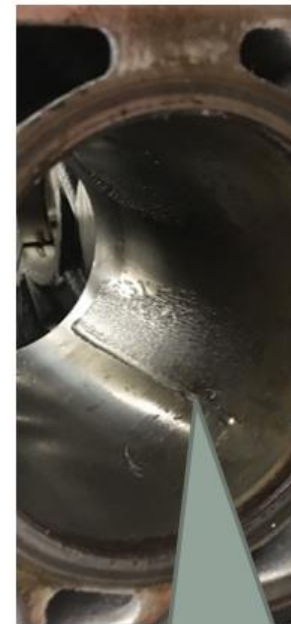
### Cylinder Wall-Unacceptable Wear

- Deep gouges or impact marks
- Loss of cross hatch
- Cracks

Loss of Cross hatch

Impact marks

Deep gouges

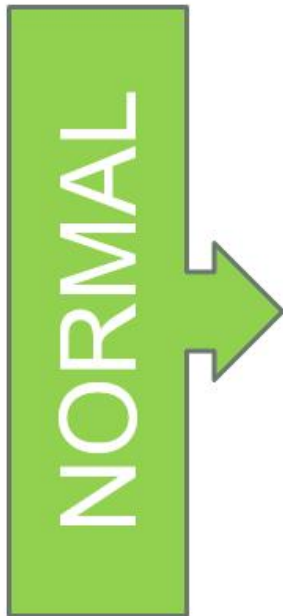
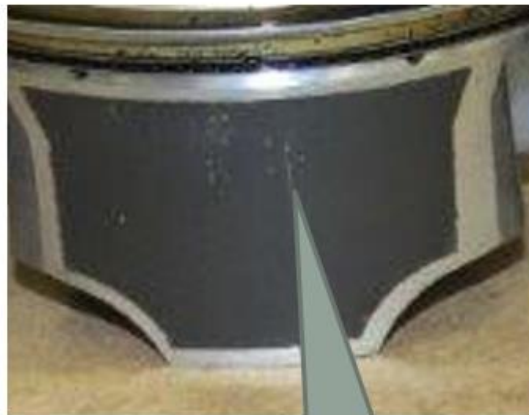
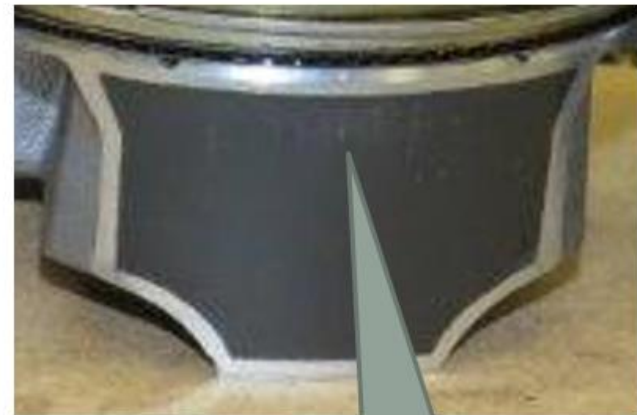
### Piston Skirt-Acceptable Wear / Conditions

Light coating wear

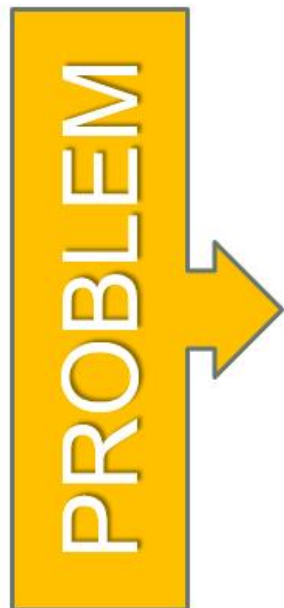
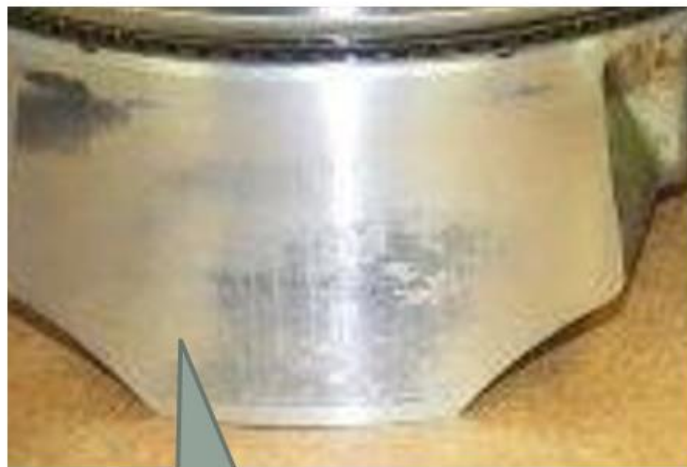
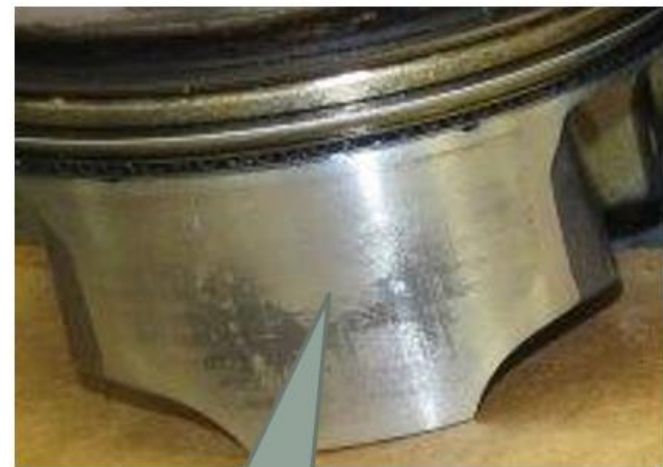
# Piston Skirt-Unacceptable Wear

Heavy coating wear

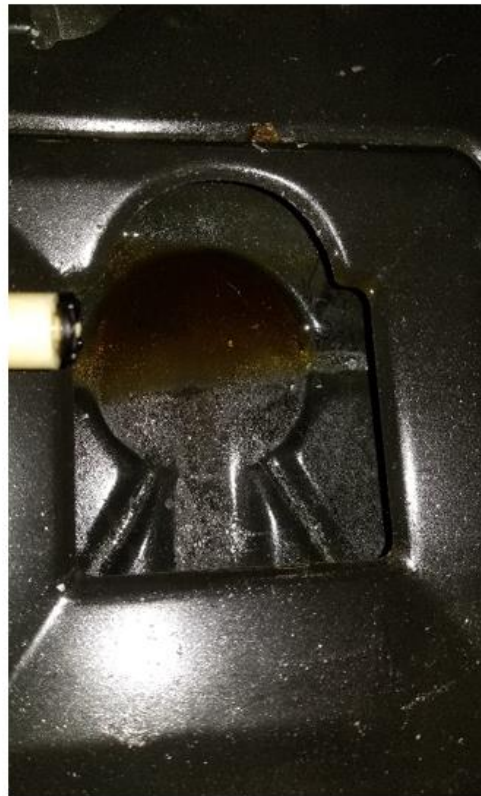
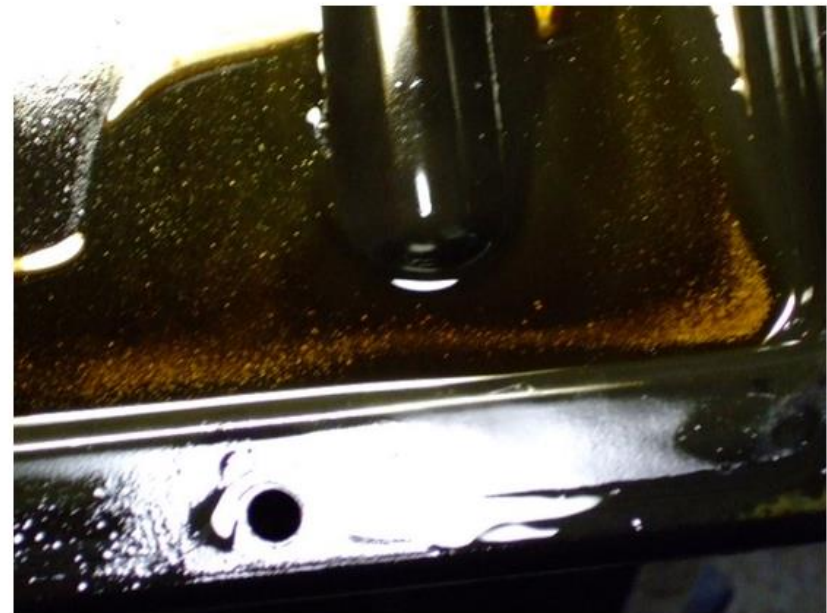
# Metal in the Oil Pan-Acceptable Conditions

Some metal shavings are not a concern

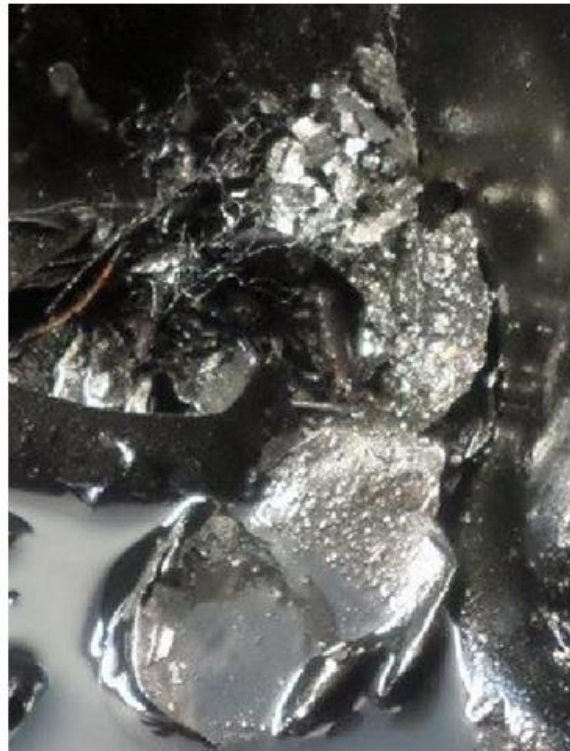
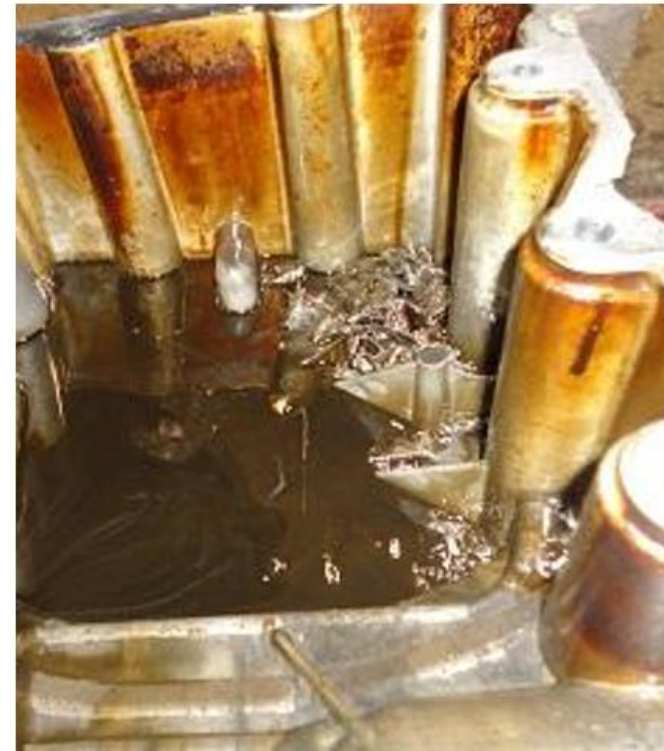
### Metal in the Oil Pan-Unacceptable Conditions

- Large quantities of metal
- Heavy accumulation in the oil filter pleats

Very large chunks merit further root cause investigation

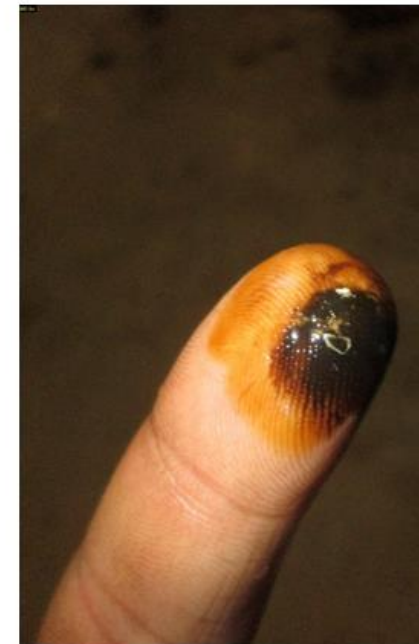
### Metal in the Oil Filter-Acceptable Conditions

A speck of metal is normal—not a problem at all!

Assembly paint is not an issue.  
**Do not confuse** with bearing material

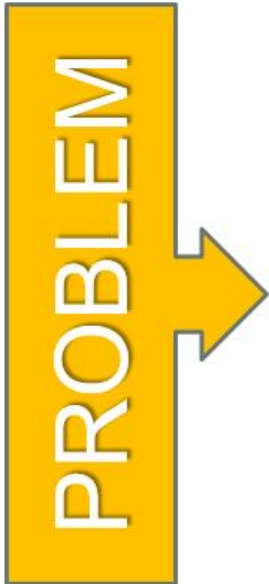
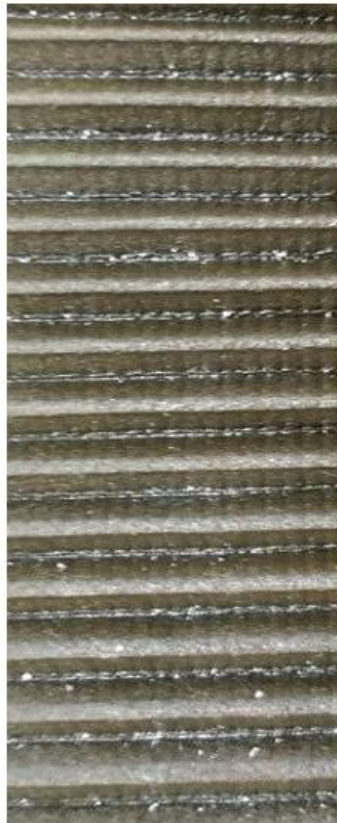
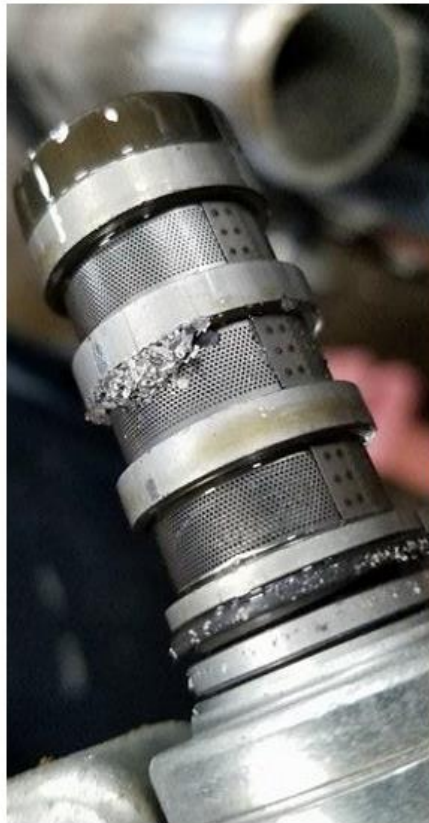
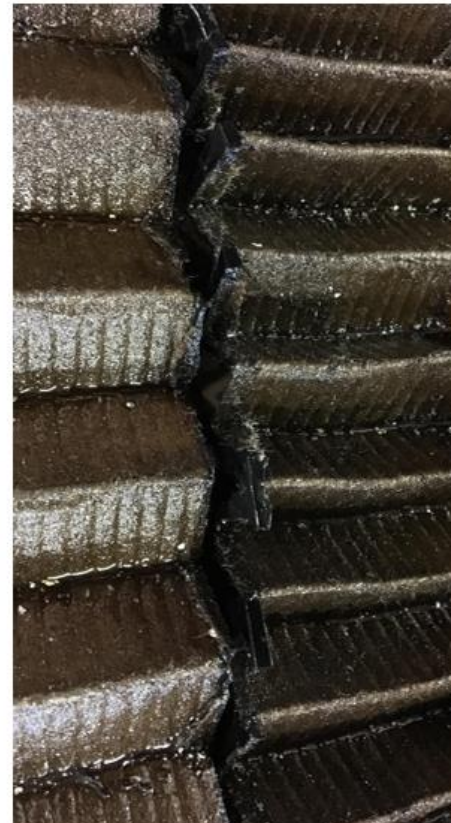
### Metal in the Oil Filter-Unacceptable Conditions

- Excessive metal = further root cause research

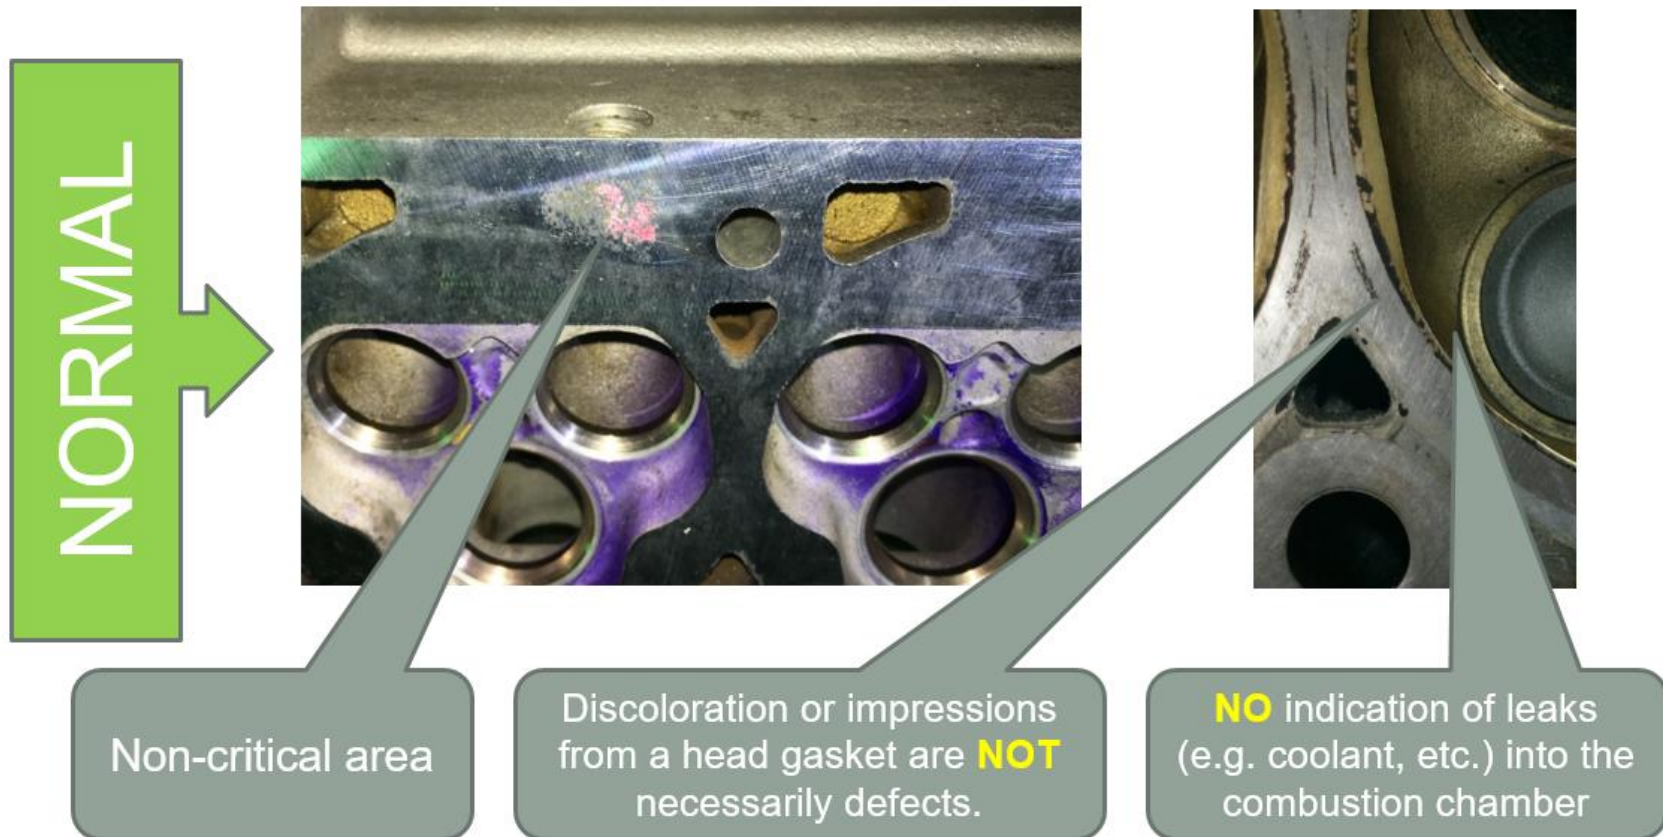
### Head and Block Deck Surface-Acceptable in Non-critical Areas

- Porosity
- Gasket sealing bead discoloration
- Scratches
- Gouges

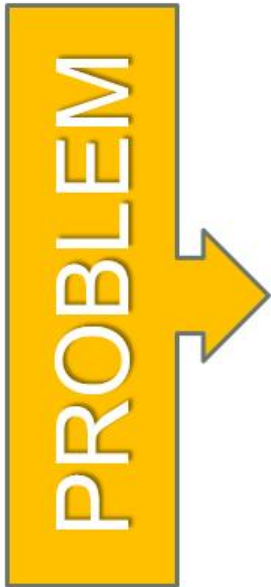
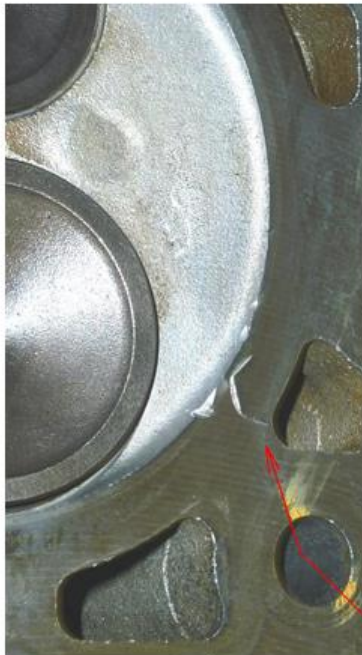
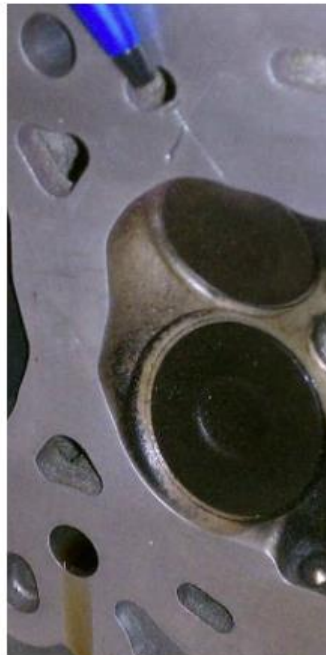
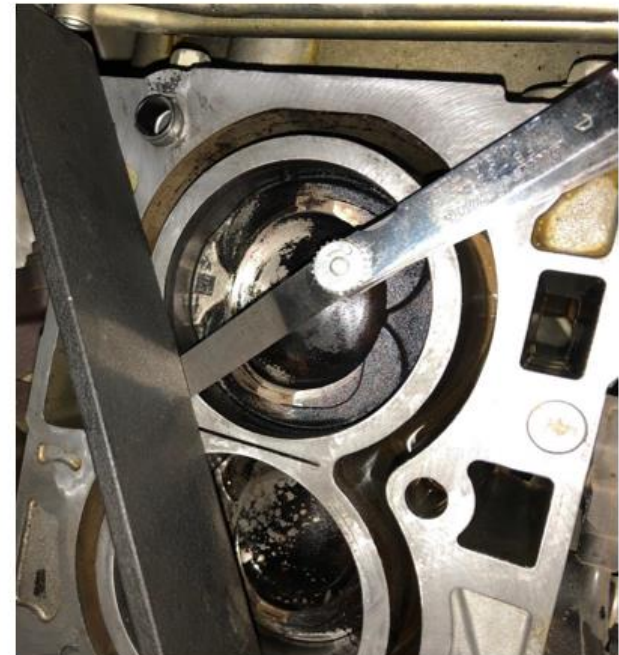
## Head and Block Deck Surface-Unacceptable in Critical Areas

Handling damage and defects in critical areas, include:

- Scratches
- Gouges
- Porosity
- Warpage

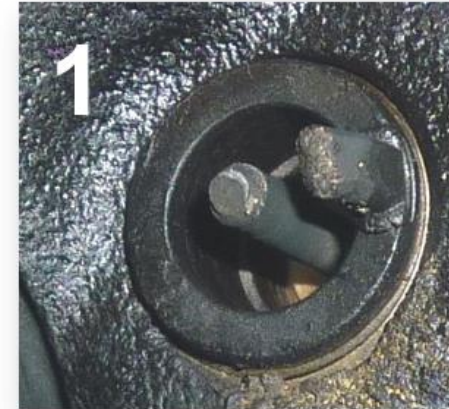
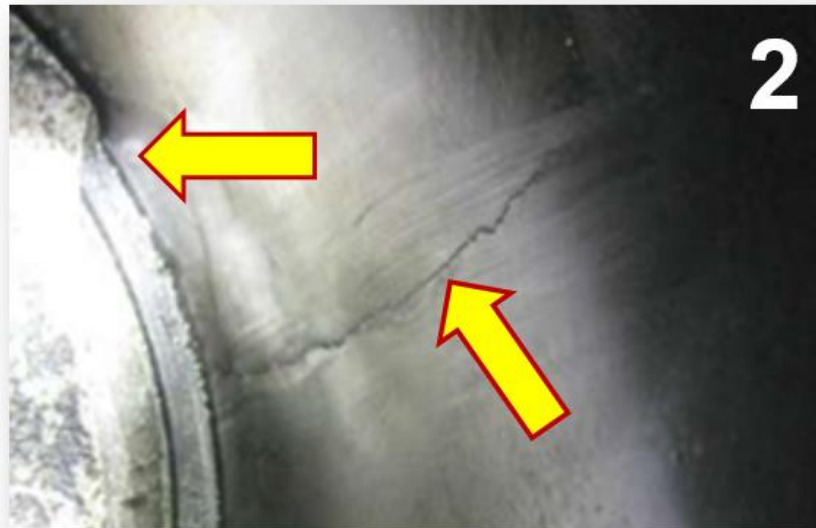
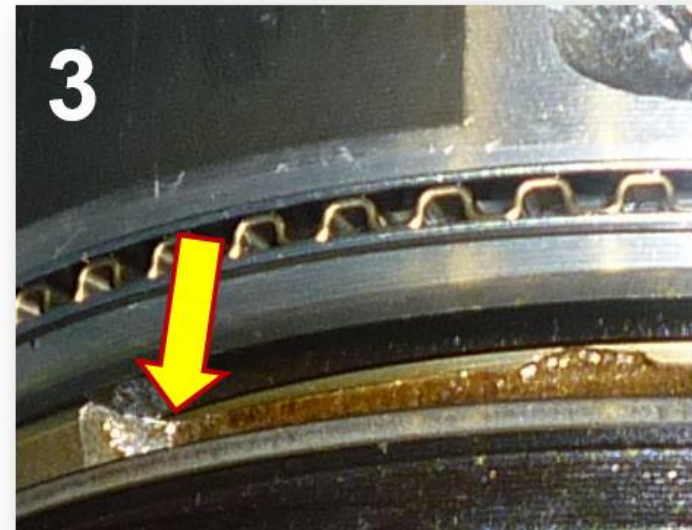
1. Spark plug damage (porcelain fractured or electrode melted off) is an indication of excessive detonation.
2. Heat generated from friction caused cylinder wall to crack (note upper ring land damage).
3. Excessive levels of detonation cause excessive cylinder pressure spikes leading to piston ring land fractures. In this instance, the less obvious second ring land is damaged.

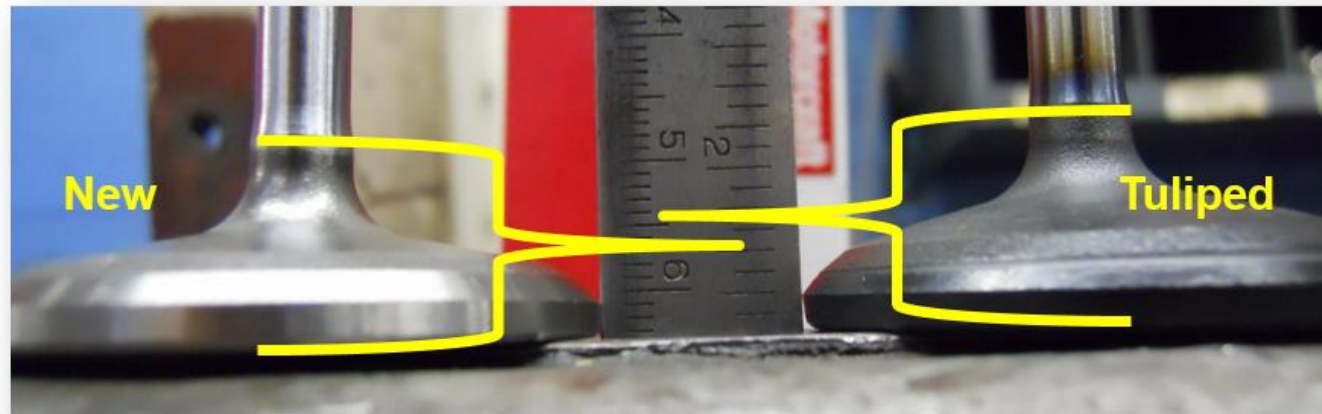
Excessively lean conditions can cause valves to overheat. As an overheated, softened valve opens and closes on the valve seat, it will deform. The valve will no longer seal on the valve seat as it stretches or “tulips” causing leakage and a misfire.

Comparing total valve height of the suspect valve to a known good valve can help identify issues. A height difference in the suspect valve is an indication of valve tuliping.

**Remember:** Valve tuliping is the effect, not root cause of the concern.

If cylinder leakage is present past the valves:

- Check for valvetrain components out of position that could hold the valve open
- Check if the valve stem is sticking in the valve guide
- Inspect for possible debris preventing the valve from contacting the valve seat

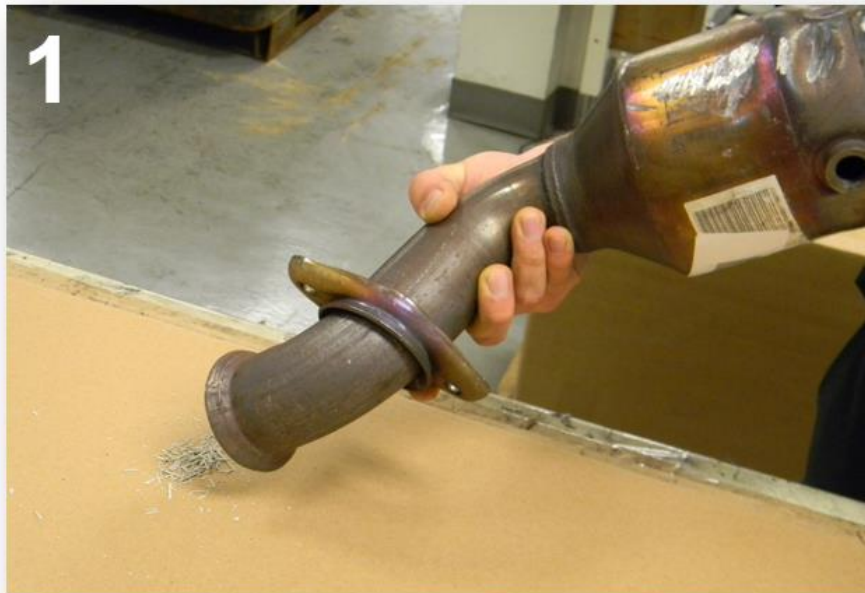
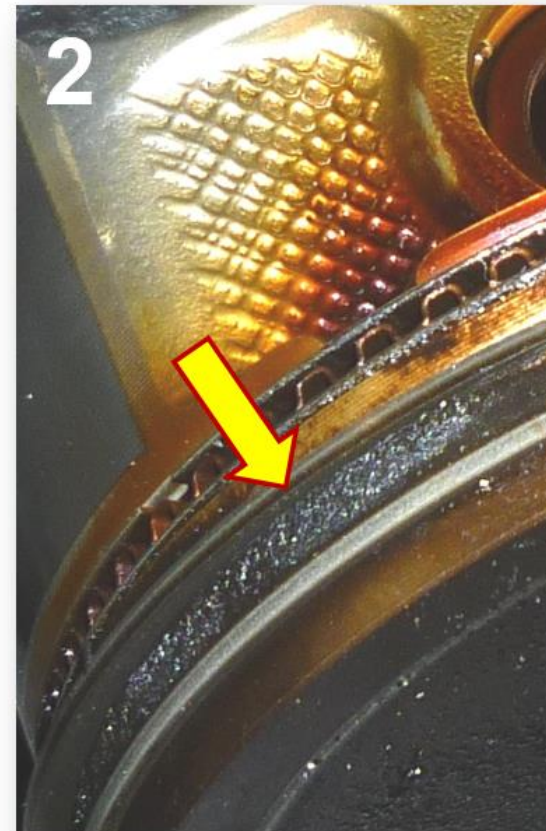
1. Inspection alone may not reveal deterioration. Tip the exhaust and check for debris falling out.
2. Catalyst material can collect on the sides of the piston damaging cylinder wall surfaces.

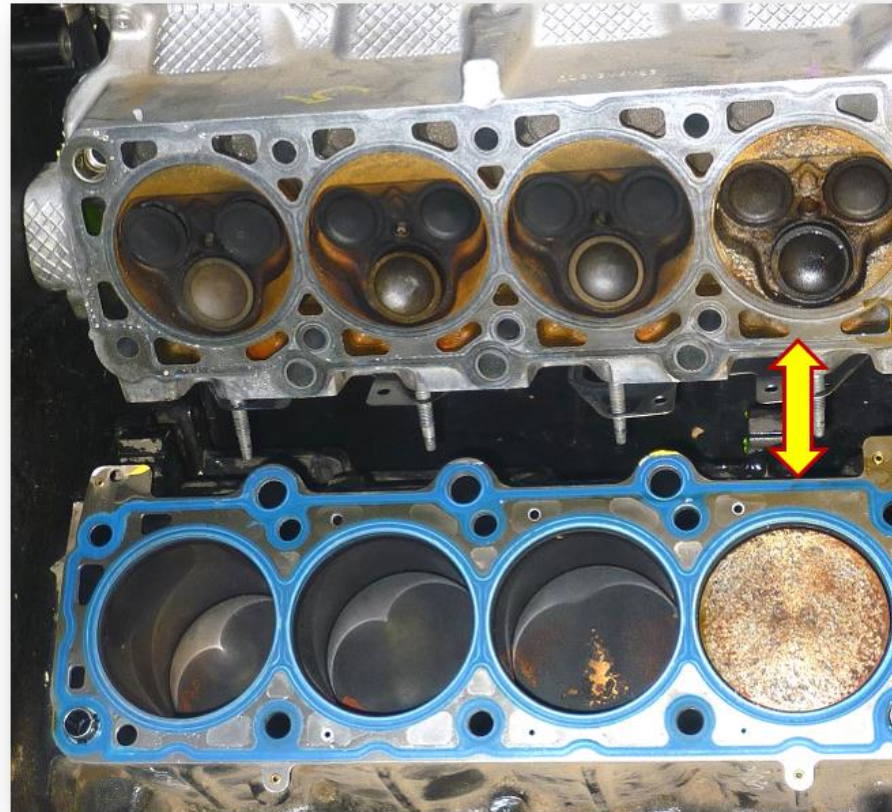
- Intake manifold must be replaced in these instances.
- Hot metal can adhere itself to the intake. Engine vacuum over time will dislodge debris damaging new engines.
- Understanding the extent of damage can help provide a complete estimate for the customer (i.e. engine + intake manifold).

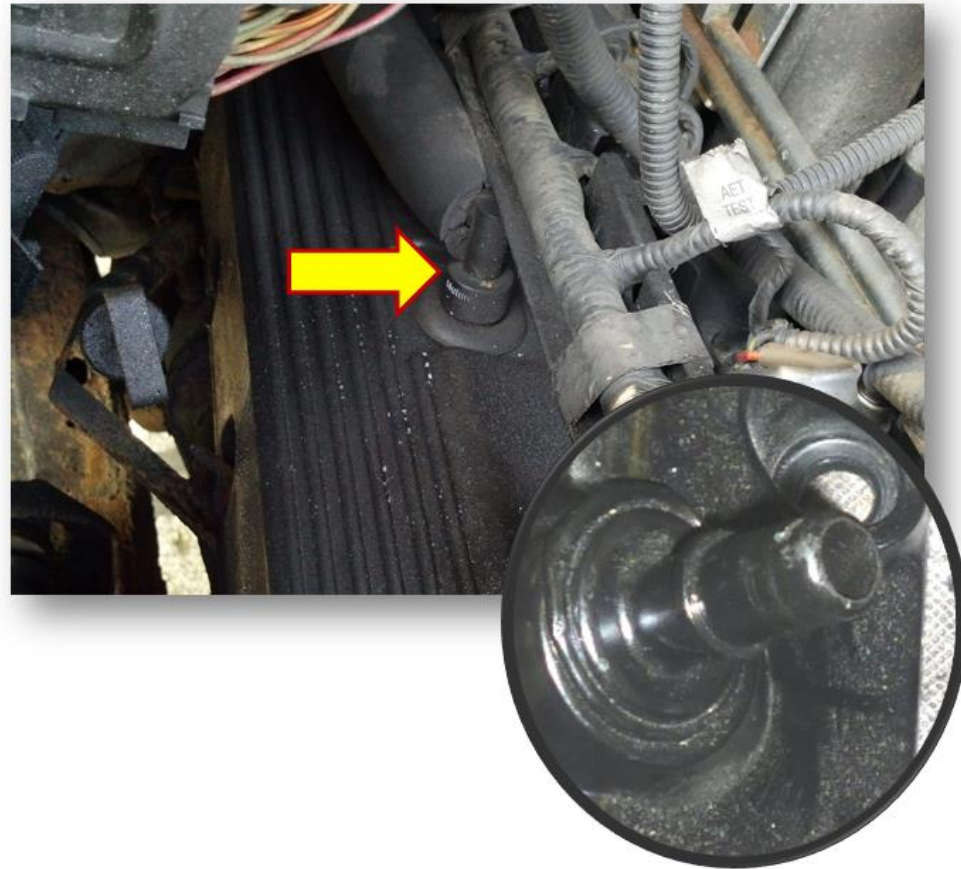
Open breather tube fitting in place of PCV valve

- **Warning:** On multiple/chain engine replacements, an open breather tube fitting (mistaken for a PCV valve) could be transferred from engine to engine causing bearing failure.
- Remanufactured Modular 2v V8 and V10 engines **NEVER** come with a PCV valve installed.
- If a PCV valve appears to be in place on a newly-installed Remanufactured 2v V8 or V10 engine, **REPLACE** it.
