General Service Bulletin (GSB):	Engine Failure Analysis and Tips
GSB Overview:	This bulletin provides tips to assist the dealership when performing engine diagnostics and root cause determination.
NOTE: This information is not intended to replace or supersede any warranty, parts and service policy, Work Shop Manual (WSM) procedures, PC/ED procedures or technical training or wiring diagram information.

# **Engine Failure Analysis and Tips Job Aid**

Guide to Engine Analysis and Preventing Repeat Engine Failures

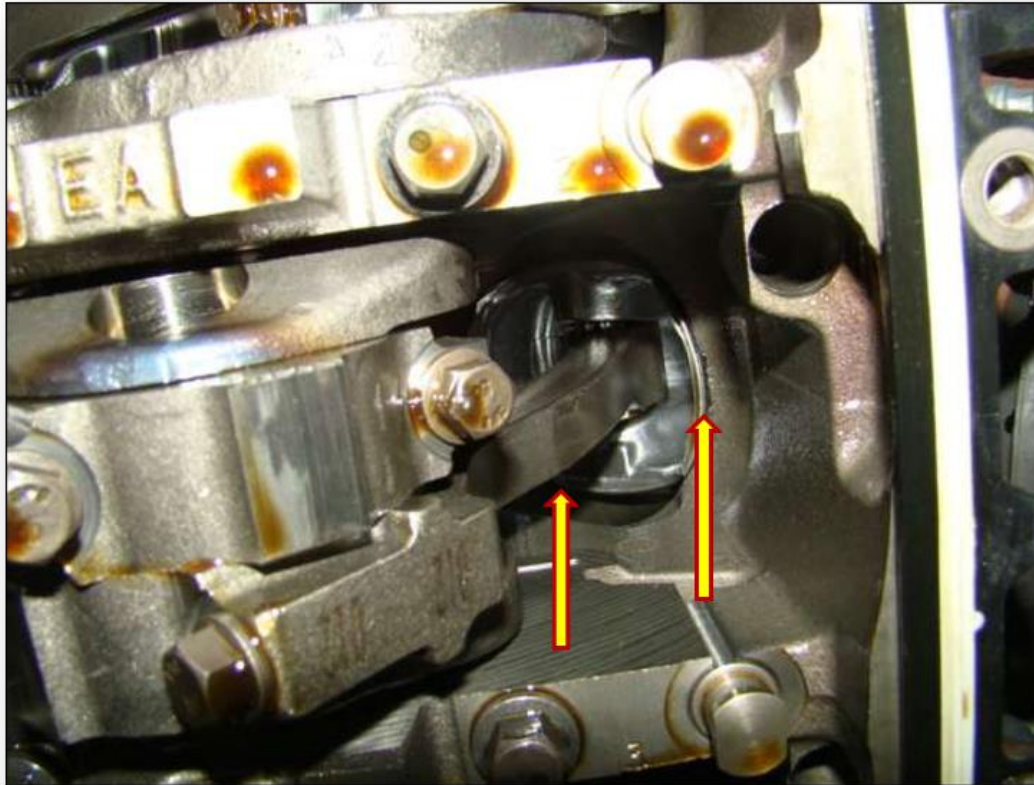
Since fluids cannot be compressed, the connecting rod typically suffers from a hydrolock event.
