## TECHNICAL SERVICE BULLETIN

### Various Concerns With Active Exhaust System - Built On Or Before 28-Aug-2020

**21-2011**  
25 March 2021

Ford 2020 Mustang
----------------------

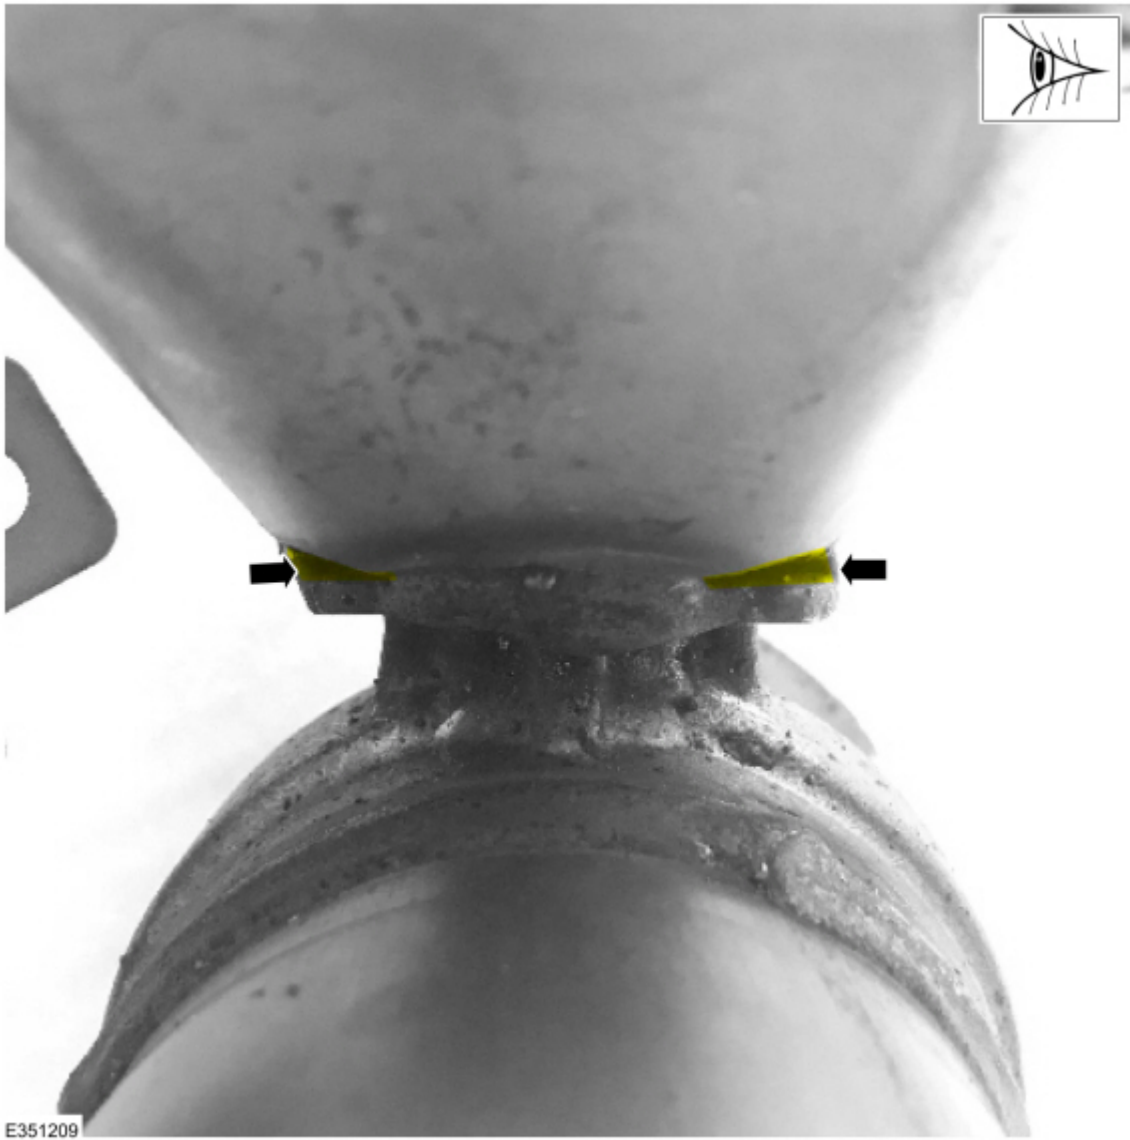
- (1). Yes - proceed to Step 3.
  - (2). No - proceed to Step 5.
3. Inspect the bracket on the tailpipe to which the exhaust actuator mounts. Make sure the bracket is mounted properly to the tailpipe by attempting to insert a 1 mm (0.39 in.) feeler gauge at the base of the bracket where it is welded to the tailpipe. Figure 1 shows a bracket that is properly welded. A feeler gauge cannot be inserted between the bracket and the boss to which it is welded. Figure 2 shows a bracket that is improperly welded, leaving room for the feeler gauge to be inserted.

4. If this feeler gauge can be inserted between the bracket and the tailpipe at any point where the bracket and tailpipe meet, replace the muffler and tailpipe.
5. Inspect the muffler and tailpipe for proper position in the exhaust clamps that secure them to the rest of the exhaust system. Make sure the knurled area of the tailpipe meets the exhaust clamp as shown in Figure 3. If the knurled area of the tailpipe does not meet the exhaust clamp as shown in Figure 4, loosen the clamp and shift the muffler and tailpipe forward until the knurled area meets the exhaust clamp.

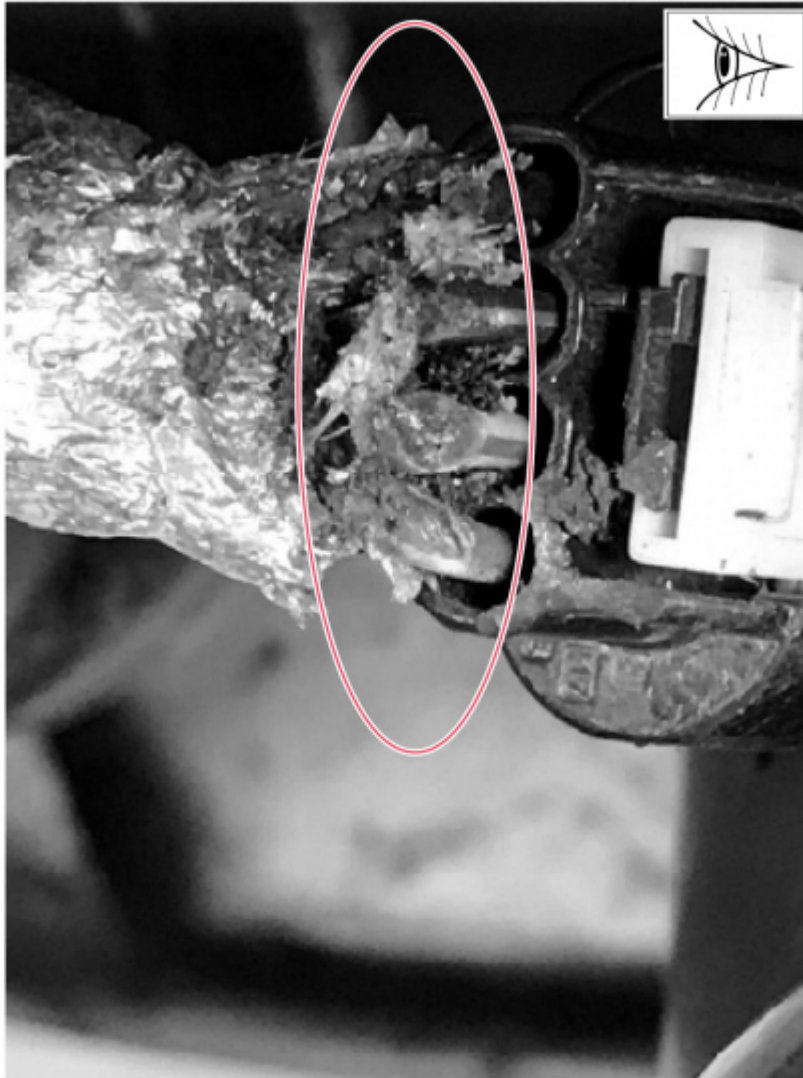
Figure 5

6. Inspect the wiring harness near the area of the tailpipe actuators for signs of damage or chafing as shown in Figure 5. Repair as necessary. Refer to Wiring Diagram, Section 5.
