## CERTAIN 2015-2017 MODEL YEAR MUSTANG VEHICLES — LUGGAGE COMPARTMENT LID WIRING INSPECTION AND REAR VIEW CAMERA IMPROPER FUNCTION

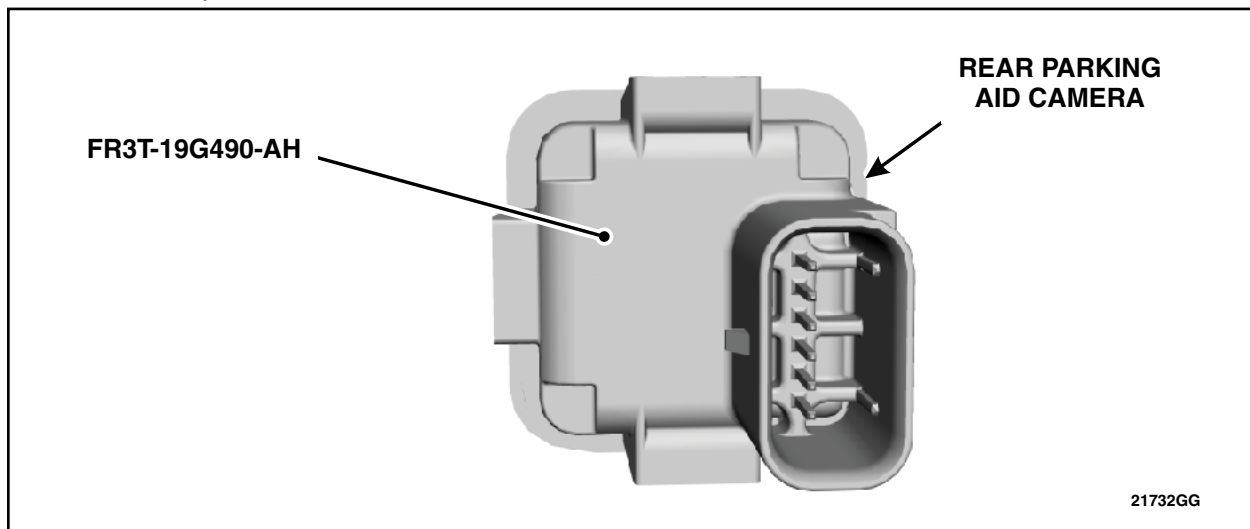
FIGURE 1

4. With the rear parking aid camera out of the vehicle, inspect the engineering part number on the back of the camera. See Figure 1.

- Is the part number FR3T-19G490-AH?

YES - Reinstall the Rear Parking Aid Camera. Please follow the WSM procedures in Section 413-13B. Do not install the luggage compartment lid trim at this time. Proceed to Step 6.

NO - Replace the Rear Parking Aid Camera. Please follow the WSM procedures in Section 413-13B. Do not install the luggage compartment lid trim at this time. Proceed to Step 5.
