FORD:

2015 Mustang

Some 2015 Mustang Coupe vehicles built on or before 11/10/2014 may exhibit a wind noise from the area of the upper windshield. This may be caused by a sealer skip at the front edge of the roof ditch joint resulting in a pinhole.

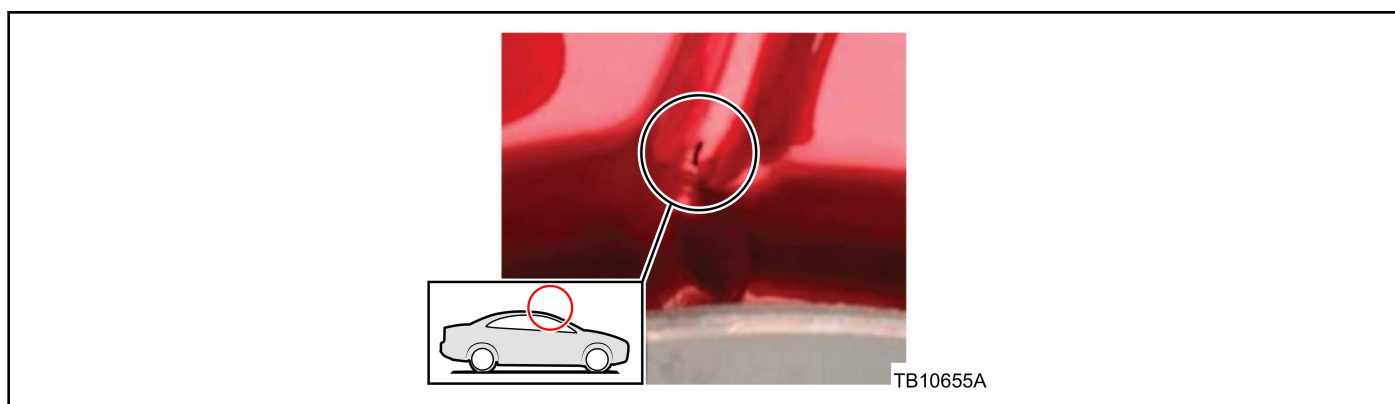
Figure 1 - Article 15-0025

1. Check the front edge area of the roof ditch joint at the upper windshield for a pinhole or sealer skip. Is a pinhole or sealer skip evident? (Figure 1)

- a. Yes - proceed to Step 2.
 - b. No - this article does not apply. Refer to Workshop Manual (WSM), Section 501-00 for normal diagnosis.
2. Apply Motorcraft® Seam Sealer or equivalent paintable sealer and apply the appropriate color touch up paint.
