TECHNICAL SERVICE BULLETIN

17-2068
18 April 2017

SYNC 3 – No Rear View Camera Image At Freezing Ambient Temperatures - Built On 01-Jul-2015 And Through 31-Dec-2016

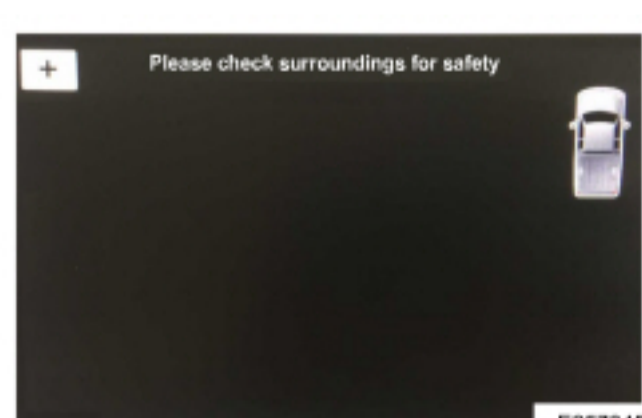
Figure 1

- Was the vehicle built on or after 01-Jul-2015 and through 31-Dec-2016?
 - Yes – proceed to Step 2.
 - No – this article does not apply. Refer to Workshop Manual (WSM), Section 413-00 for normal diagnostics.
- Is the customer reporting a SYNC display message of Please check your surroundings for safety along with no rear view camera image when in reverse gear which occurs during an ambient temperature range of -5 °C to 5 °C (23 °F to 41 °F)? (Figure 1)
 - Yes - proceed to Step 3.
 - No - this article does not apply. Refer to WSM, Section 413-00 for normal diagnostics.

- Start the engine and set the heating ventilation air conditioning (HVAC) controls to maximum heat with blower speed on high. Run the engine until it reaches normal operating temperature. This will allow the accessory protocol interface module (APIM) to reach normal operating temperature. Is the SYNC system displaying a message of Please check your surroundings for safety along with no rear view camera image when in reverse gear (Figure 1)?
 - Yes - this article does not apply. Refer to WSM, Section 413-00 for normal diagnostics.
 - No - replace the APIM. Refer to WSM, Section 415-00.
