## TECHNICAL SERVICE BULLETIN

### 2020-2021 Mustang Shelby GT500 - Hood Inner Panel Cracks

**21-2155**

<b>Ford</b> 2020-2021 Mustang Shelby GT500
---

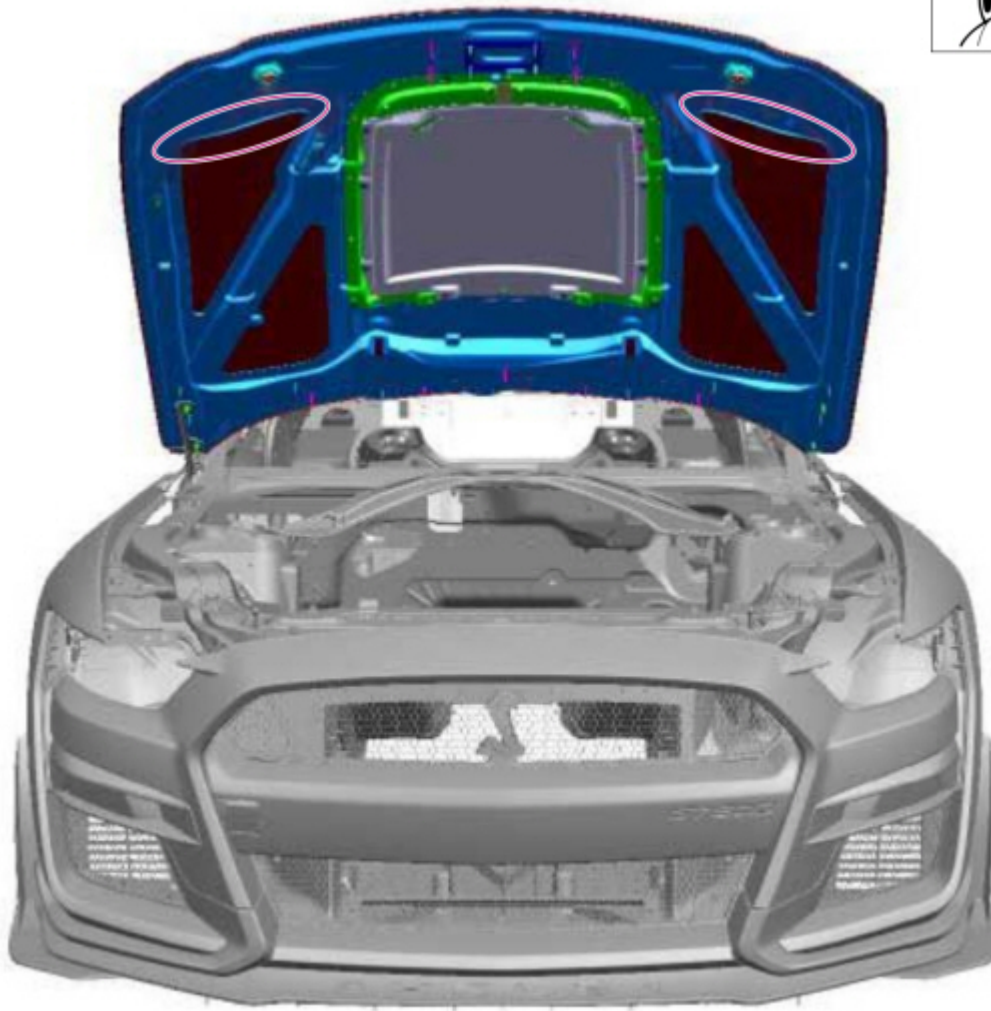
Figure 1

**Issue:** Some 2020-2021 Mustang Shelby GT500 vehicles may exhibit a cracking on the hood inner panel. The crack is a cosmetic condition, not a structural concern. This may be due to a variation in production of the hood. To correct the condition, follow the Service Procedure to repair the hood crack.

1. Lightly sand the affected area using 400-600 grit sandpaper.
2. Prepare the cracked surface by spraying an alcohol/water mixture on a microfiber cloth and using it to clean the surface.
3. Create typical body filler by mixing resin and hardener following manufacturer specifications. Mix enough to last 2 minutes.
4. Using a plastic blade, apply thin layers to fill the void. Use a front, back, and side to side motion. Make sure the material is bordered on all sides.
5. Allow the body filler to dry for a minimum of 15 minutes or as specified by manufacturer.
