General Service Bulletin (GSB):	Leather / Vinyl Seat Covers
GSB Overview:	Use this GSB to help determine warrantable / non-warrantable conditions on Leather / Vinyl Seat Covers
NOTE: This information is not intended to replace or supersede any warranty, parts and service policy, Work Shop Manual (WSM) procedures or technical training or wiring diagram information.

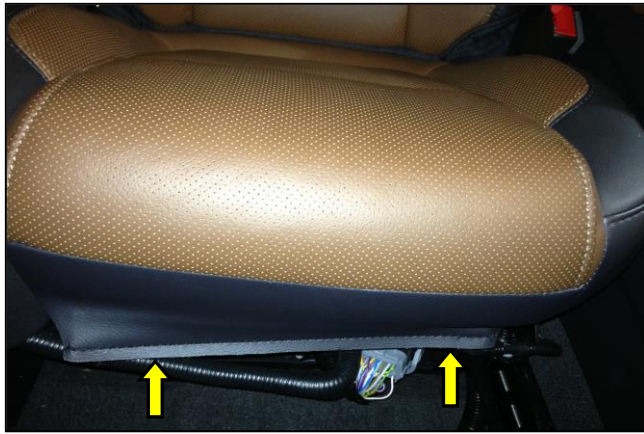
**Figure 1** – Loose seat trim cover typically caused from loose/detached retention J-clips. Loose J-clips can be repaired/re-attached per Warranty and Policy Manual. J-clip loose from material can be re-sewn

*Replacement of Seat Cover for a loose/detached J-Clip or wrinkles / loose material would be considered an over repair and not warrantable. Refer to page 1.*

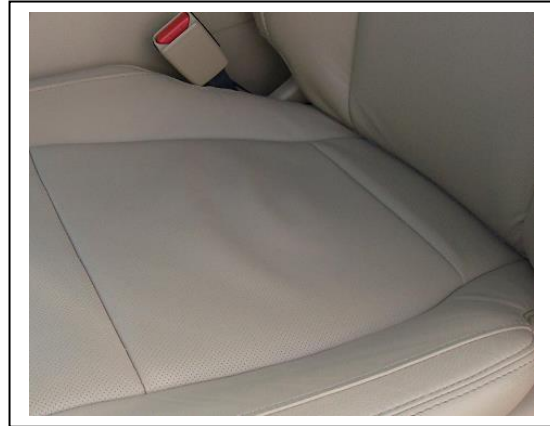
**Figure 2** – Misaligned/loose seat trim covers must be corrected through adjustment. Refer to WSM Section 501-10. Stretching/looseness of the seat cushion cover center panel is a characteristic of leather seats and may not improve with adjustment

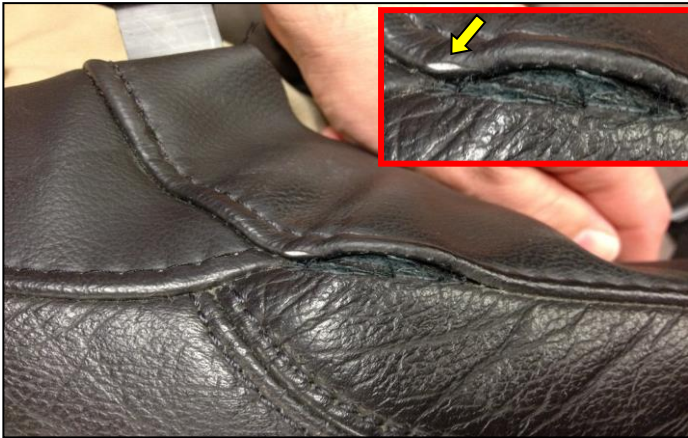
**Figure 3** – Split seam with evidence of cuts, scratches, snags, puncture or stain marks to surrounding material or thread.

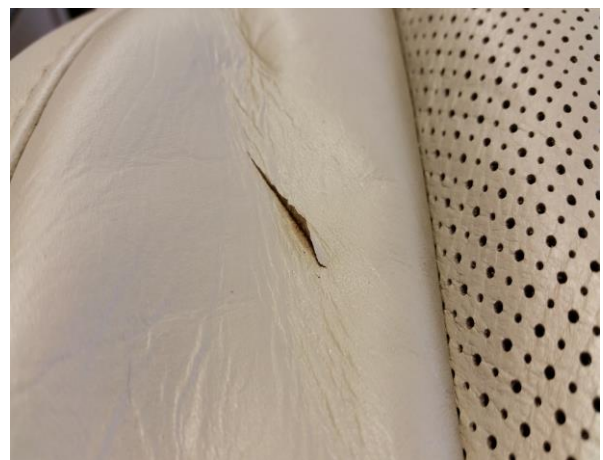
**Figure 6** – Cut in leather (mistaken as leather top coat peeling) leather russet still attached to underside of top coat

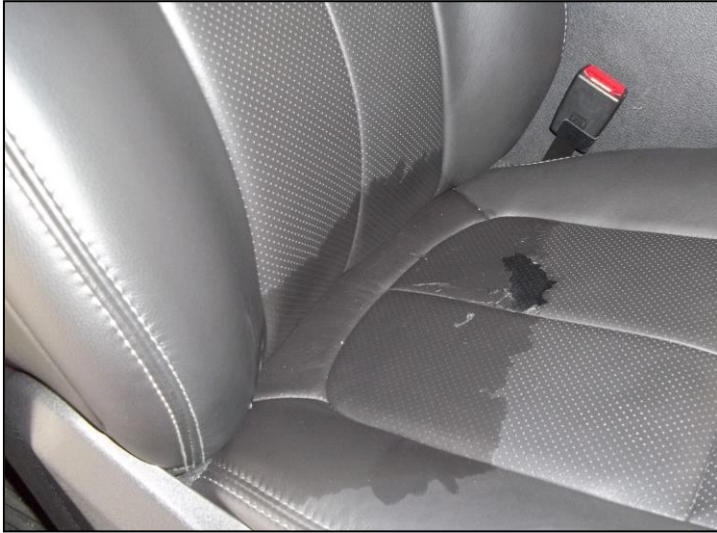
**Figure 7** – Chemical damage resulting in discoloration typically across multiple panels and or a peeling surface

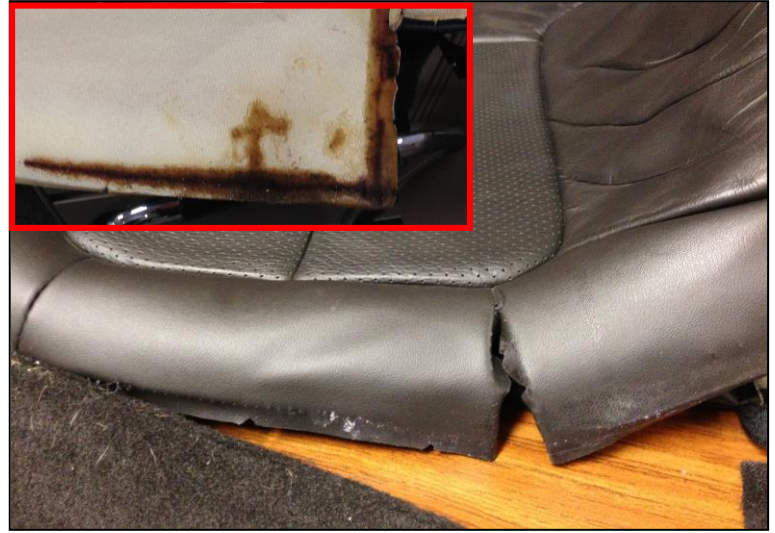
**Figure 8** –Seams split caused by chemicals which break down stitching

*Evidence of staining on back side of cover*

**NOTE: Some reviews of returned seat trim covers for loose/missing stitching concerns have been found to be caused by chemical/fluid damage. This is evidenced by staining on the front and / or back side of the seat trim cover.**

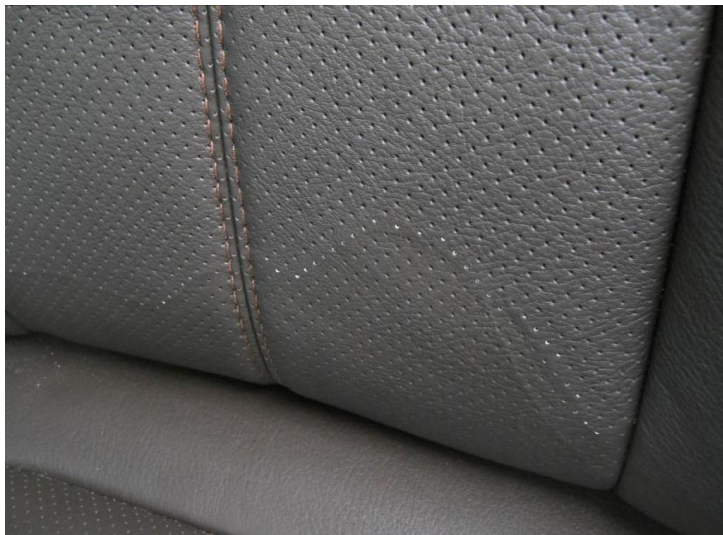
**Figure 9** - Liquid Damage that spans across multiple leather panels that may appear to be a natural scar. Once a liquid is allowed to soak in the leather and then left to dry, a raised edge may appear that feels rough to the touch

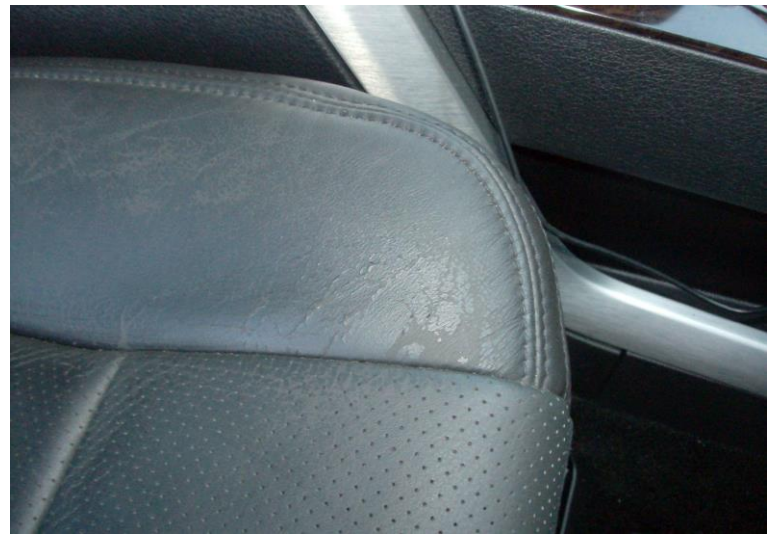
**Figure 10** – Failed repair attempt such as vinyl dye/painting, evidenced by smooth/shiny surface and lack of the natural leather grain. Overspray on thread or other panels is an indication of vinyl dye/painting

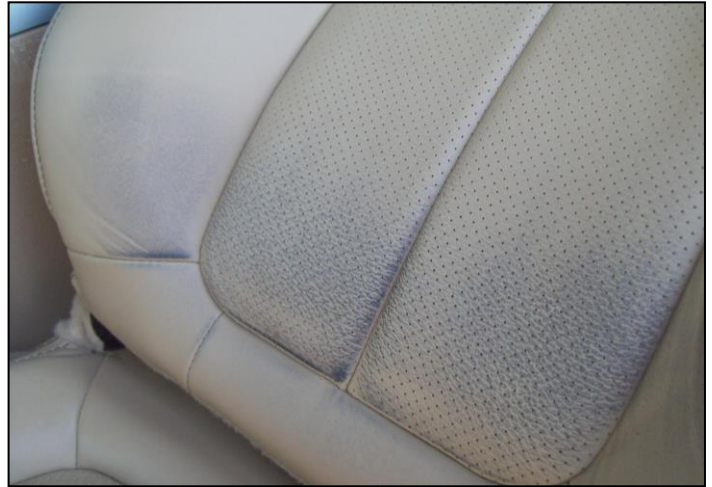
**Figure 12** – Dye (colors may vary) transfer from clothing resulting in discoloration

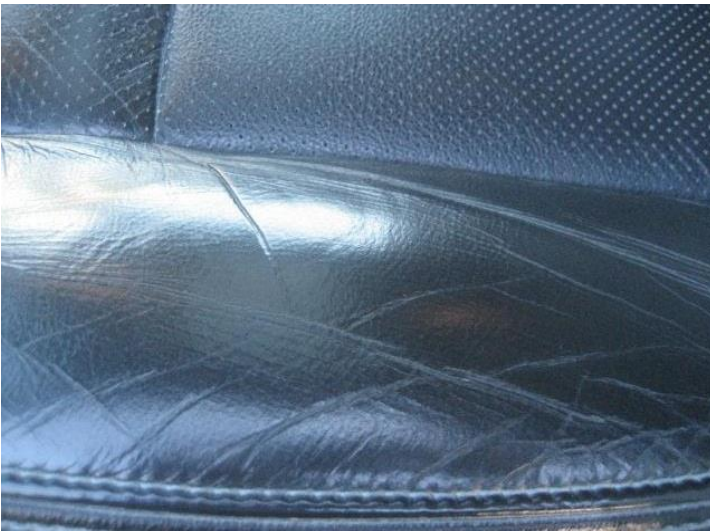
**Figure 13** –Leather wrinkles  
Leather/Vinyl character lines/wrinkles due to normal wear.

*Proper cleaning and conditioning will often reduce the appearance of wrinkles.*

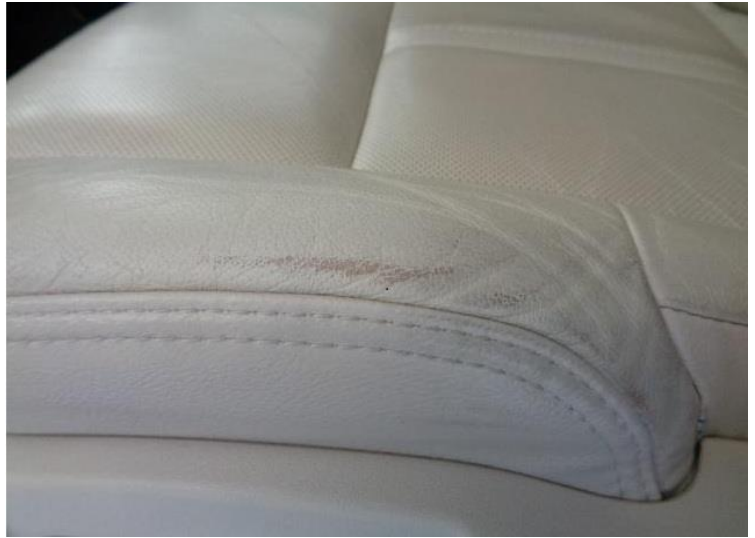
**Figure 16 – Ingress/Egress Wear**  
Top/Color coat is worn (smoothly not scratched) off from entering/exiting the vehicle. Leather subsurface is visible. Tip: Leather russet will darken when wiped with a damp cloth

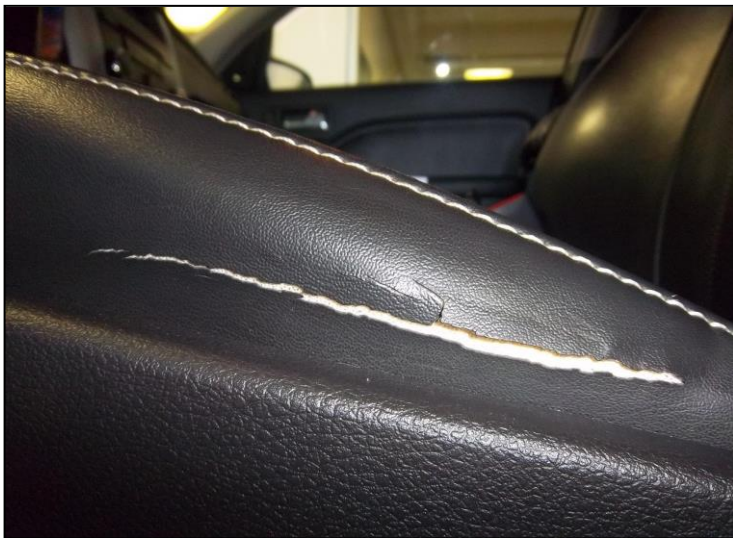
**Figure 17** – Cracking on side bolster (jagged lines) not caused by cuts/snags

*Carefully inspect for hard & brittle material as vinyl / leather will still be soft and malleable if concern was not influenced from an outside source, i.e. chemicals.*

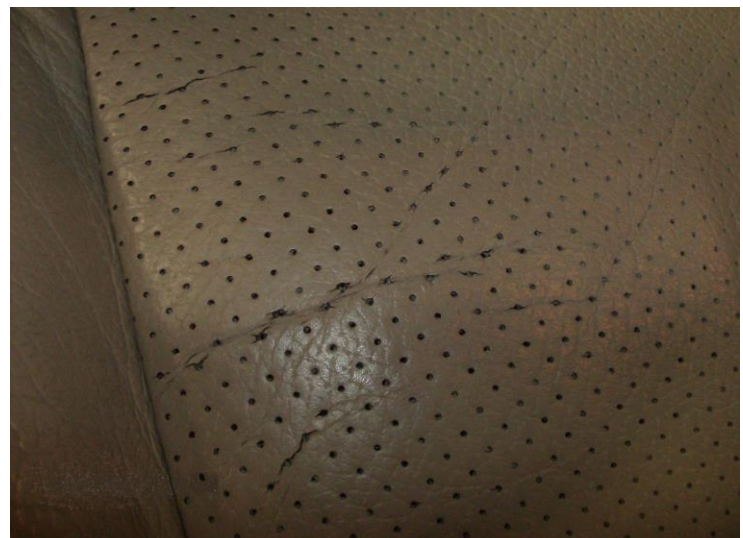
**Figure 18** – Cracking between perforations not caused by cuts/snags/chemical damage

*Carefully inspect for hard & brittle material as vinyl / leather will still be soft and malleable if concern was not influenced from an outside source, i.e. chemicals.*

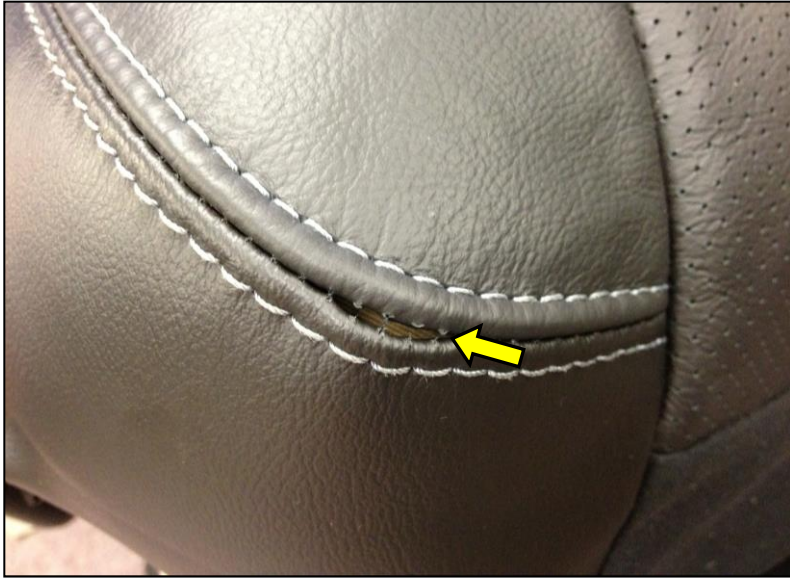
**Figure 19** – Split seam with no evidence of staining/cuts/scratches/damage to threads and surrounding area

- Split seams caused by loose or broken thread must be re-sewn.  
**NOTE: Front seat backrest trim covers installed on seats equipped with seat side air bags cannot be repaired. A new trim cover must be installed.** Refer to Workshop Manual (WSM), Section 501-10, Disassembly and Assembly, Seat Backrest.
- Misaligned/loose seat trim covers must be corrected through adjustment. Refer to WSM, Section 501-10, Removal and Installation procedures.
- Loose seat trim cover J-clips can be either reattached or secured in place by alternative means such as adhesive/screws. If necessary, most trim shops can replace J-clips without the need for seat trim cover replacement.
- Loose seat trim cover J-clips from the material may be re-sewn.

*Refer to **Repair** section on page 1*

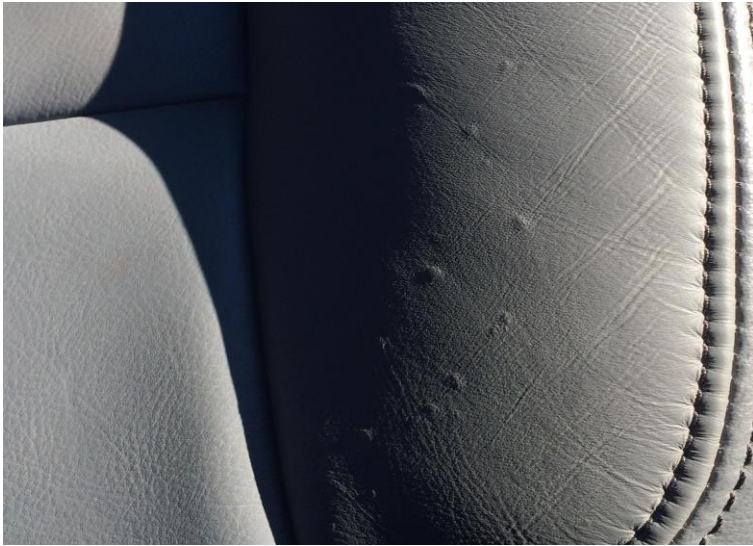
**Figure 21** – Bumps/blisters on the surface

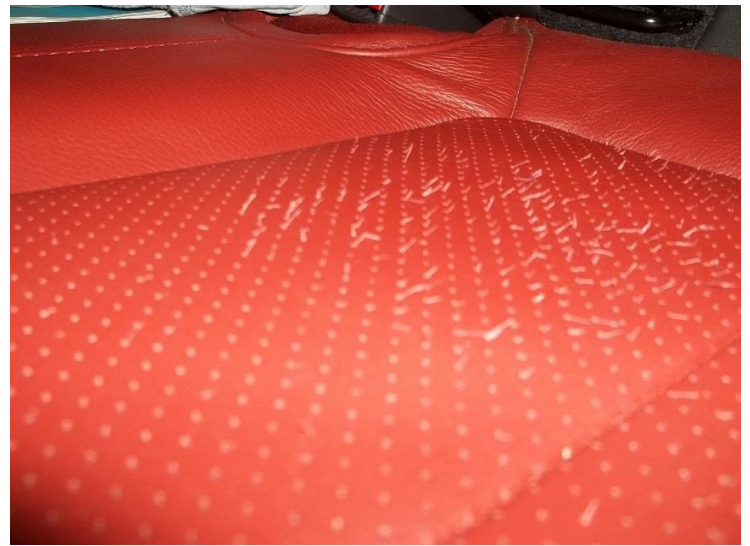
**Figure 22**– Bearding is the result of the foam backing rubbing the backside of the cover, causing fibers from the backing to come through the perforations in the leather
