## TECHNICAL SERVICE BULLETIN

### Poor Air Conditioning (A/C) Performance - Evaporator Can Now Be Serviced Separately From The Climate Control Housing

**18-2256**

Ford  
2015-2017 Mustang

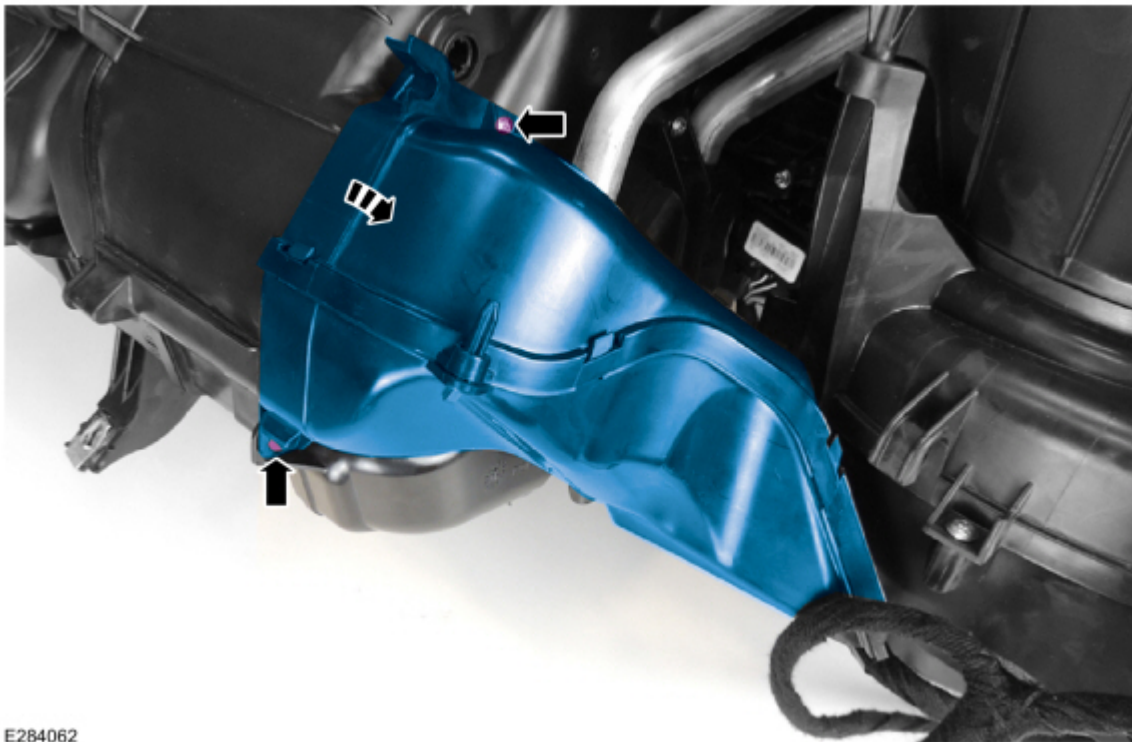
7. Remove the 2 footwell duct to climate control housing fasteners and remove the footwell duct. (Figure 6)  
Figure 6

27. Install the footwell duct to the climate control housing and install the two fasteners. (Figure 6)
28. Install the upper plenum housing to the climate control housing and position the bulkhead insulator back on. (Figure 5)

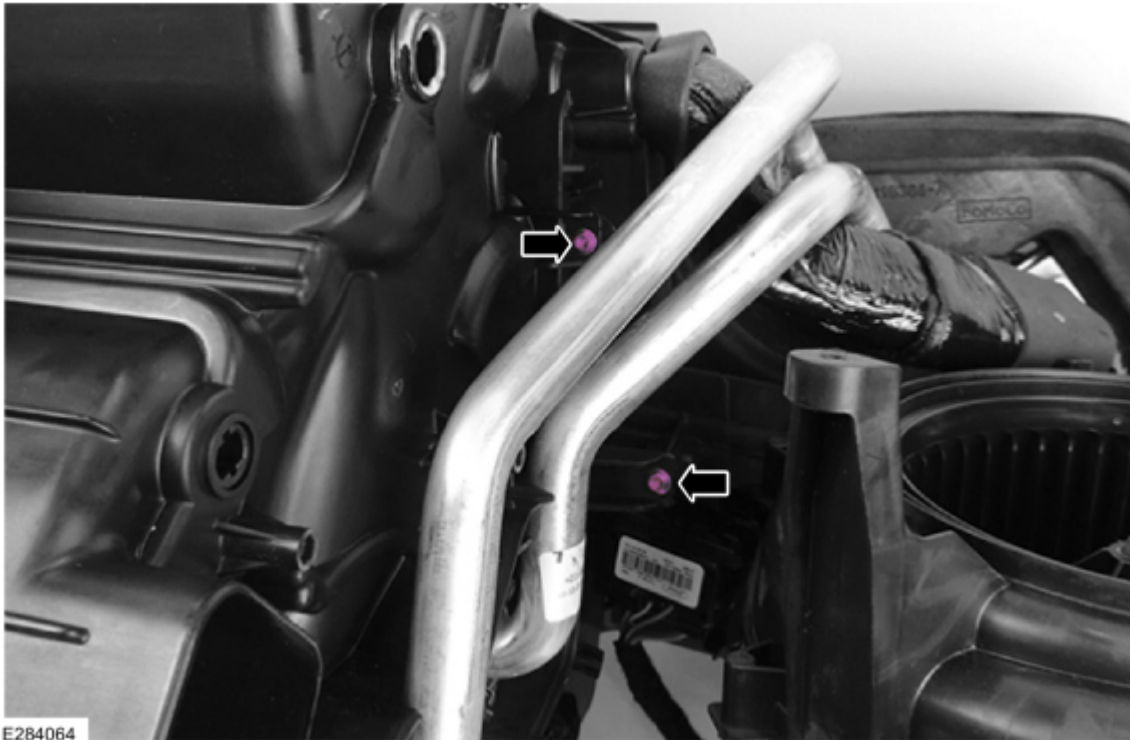
Figure 8

**9.** Remove the 2 climate control housing perimeter fasteners. (Figure 8)

25. Install the 2 climate control housing perimeter fasteners. (Figure 8)
26. Install the heater core outlet pipe cover and the 2 fasteners in the climate control housing. (Figure 7)

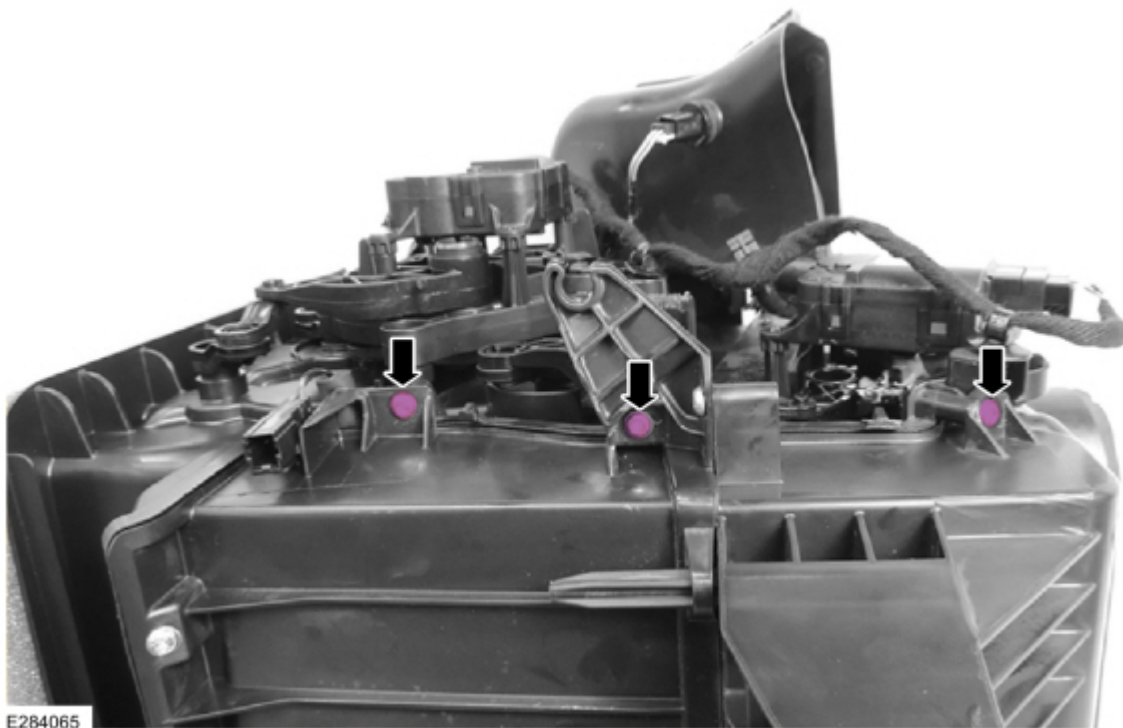
Figure 9

**10.** Remove the 3 climate control housing perimeter fasteners. (Figure 9)

**24.** Install the 3 climate control housing perimeter fasteners. (Figure 9)

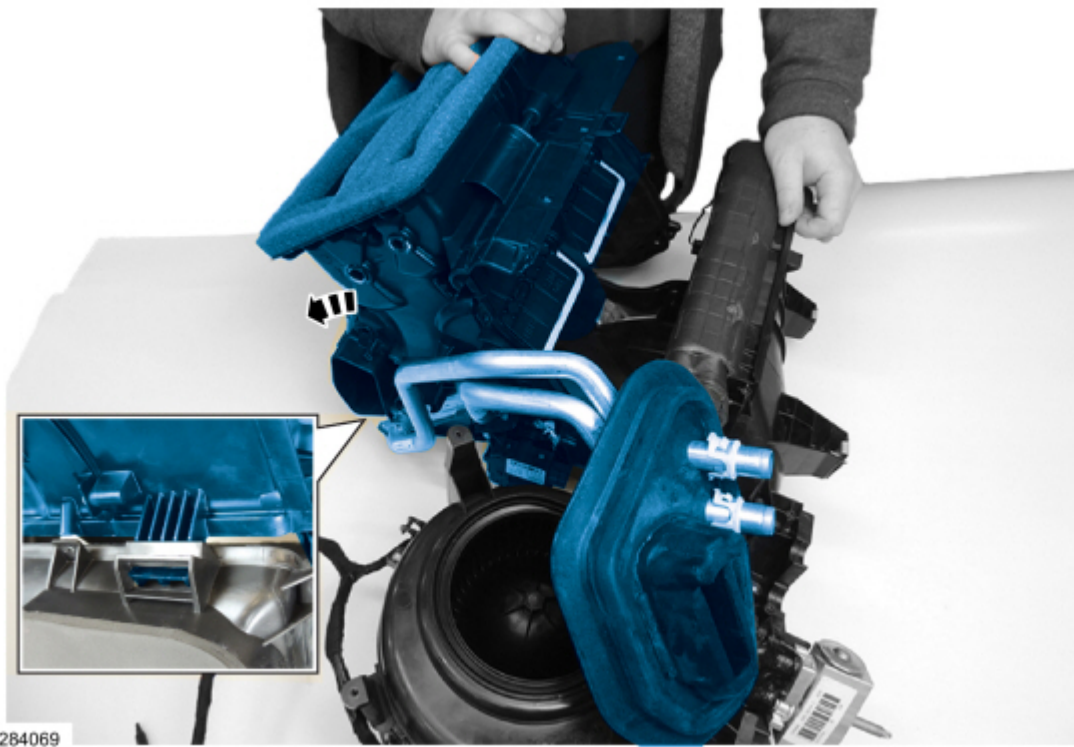
**14.** Remove the plenum chamber and heater core as an assembly from the climate control core housing. (Figure 13)  
Figure 13

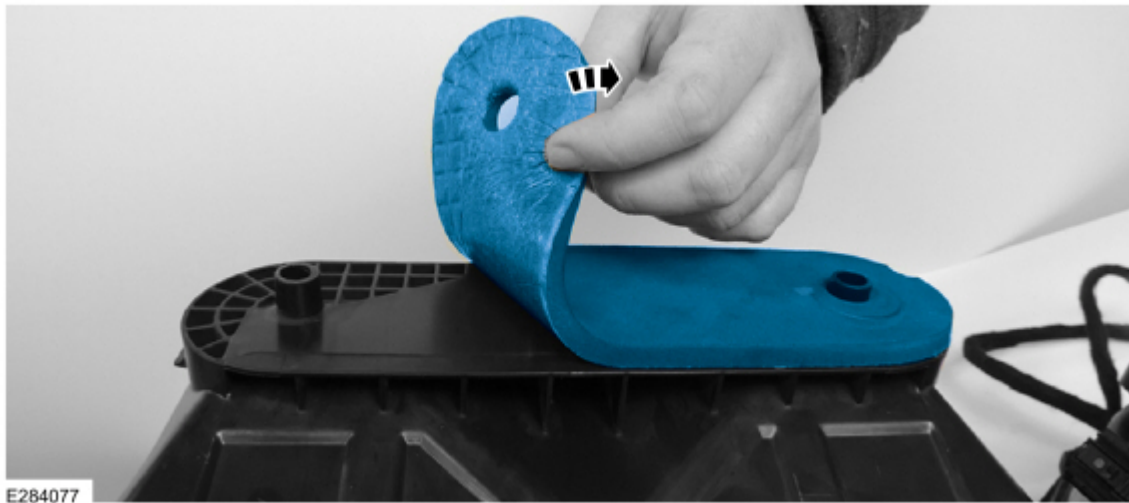
Figure 21

34. Remove the old climate control housing assembly foam isolator and apply the new foam isolator. (Figure 21)
