COMPANY OVERVIEW

CASE STUDY OVERVIEW

CASE STUDY: REPAIRING EFFECT ON ENGINE WITH EXISTING WEAR

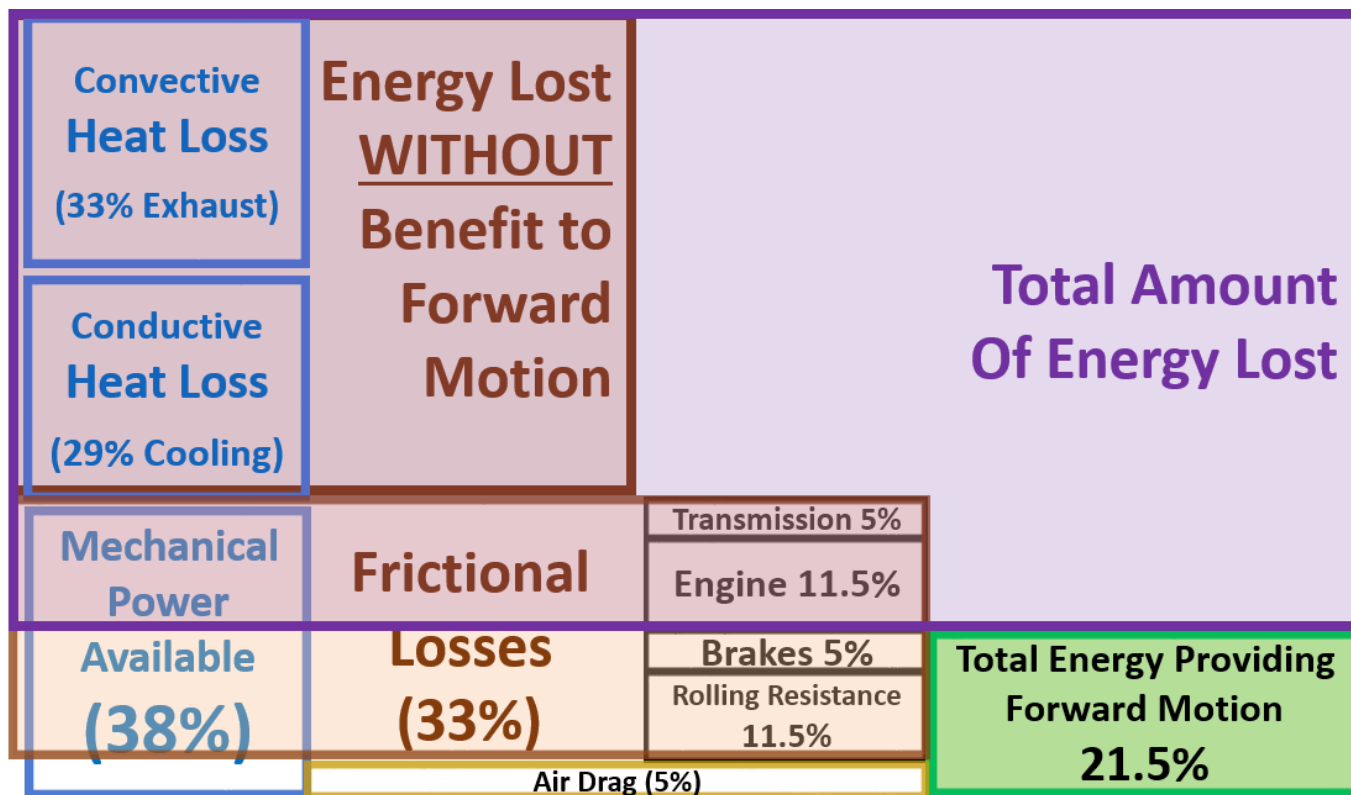
Table 1. Distribution of proportional usage of the energy derived from fuel in internal combustion vehicles⁵.

In modern automobiles, approximately, one third of the fuel consumed is wasted on internal friction¹. The energy lost (Table 1) can be attributed to individual subsystems: 11.5% is lost in engine, including a 5% loss in the cylinder/piston group and an additional 5% is loss in the transmission³.

There is an interesting nuance in the data, fuel savings are trip dependent. This clearly demonstrates that the TriboTEX coating works by decreasing internal engine friction. For the trips from a higher elevation to a lower elevation (Pullman to Colfax) engine friction makes up a larger portion of the total energy of the consumed fuel. In the scenario where the load the engine experiences increases (lower elevation to higher elevation, Colfax to Pullman) the engine friction is a smaller portion of the total energy provided by the fuel (see Table 1).

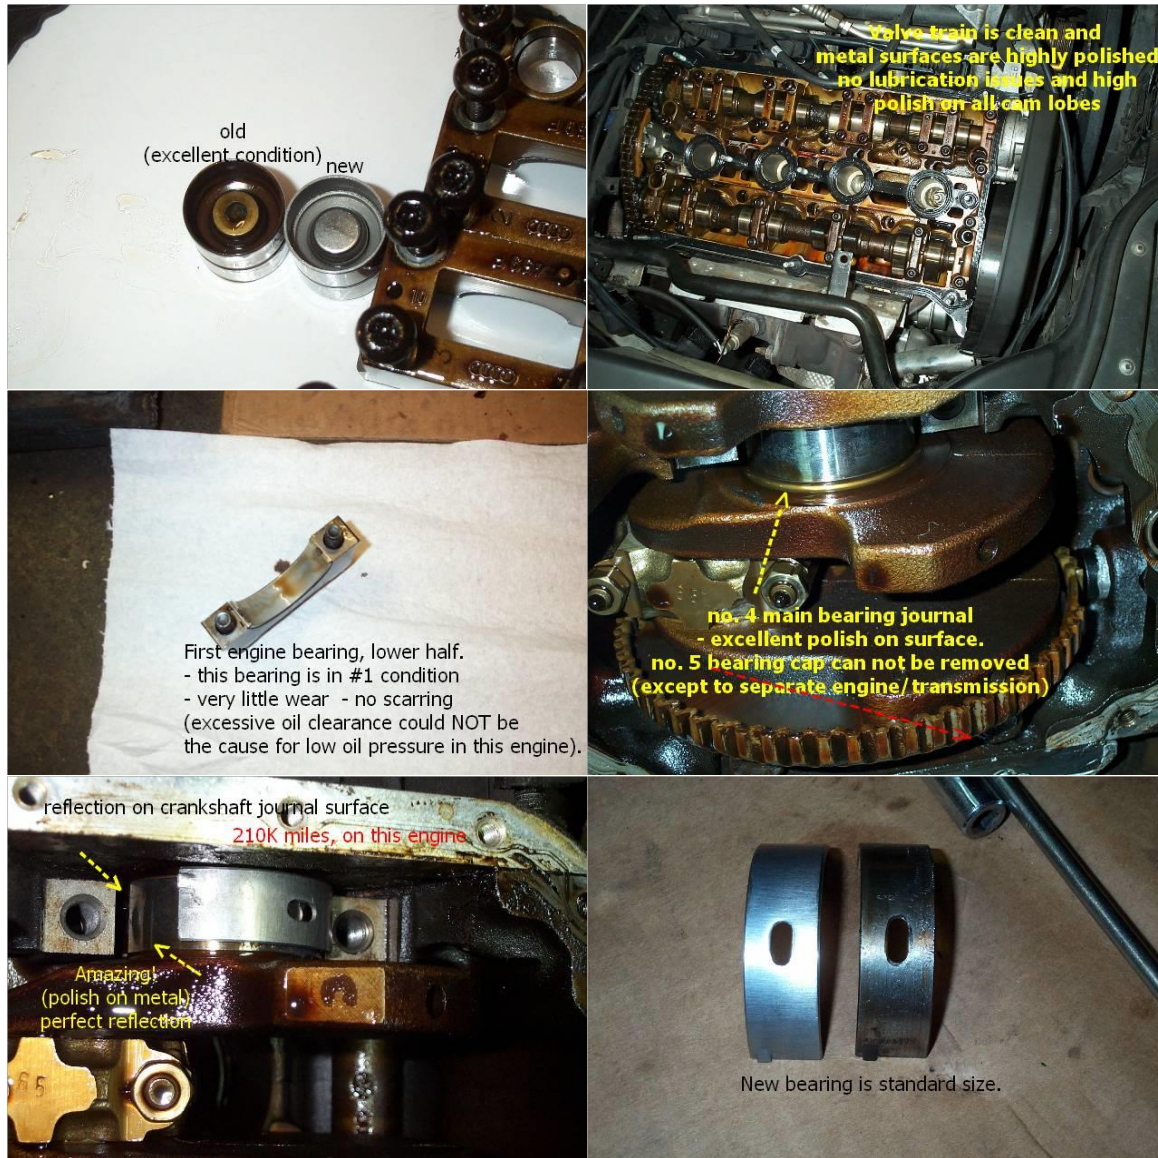
Figure 3. Selected pictures from the report provided by a mechanic. With 210K miles on the engine, MHS powder was added at 208K miles. Results were achieved in about 40 motor hours. He extracted hydraulic lifters and main journal bearings for further analysis. Our mechanic described formed film as “polish” and could not hide his admiration of the mirror smooth surfaces.

Data were collected for 32 round trips before nanoparticles treatment and 18 after the introduction of nanoparticles to the engine lubricant. Fuel economy was calculated using the on-board vehicle computer. Specifically, OBDII data from the Mass Air Flow (MAF) sensor was integrated to calculate fuel consumption. Oil pressure was measured before and after each round trip. Oil pressure measurements were taken at the normal operating temperature in two different operating regimes: at idle and at 2000 rpm. Compression testing was performed in accordance with VAG procedures outlined in the Passat manual. Briefly, the procedures called for measurements to be made with: warm engine oil, a fully depressed throttle, a fully charged battery, using 8 second starter crank intervals. After the completion of the testing interval the engine was disassembled by a local mechanic to inspect engine components for tribofilm formation (Figure 3).

The engine compartment was opened for visual inspection by a local mechanic (Figure 3). The valve cover was removed to gain access to the upper part of the engine for inspecting the coating development on the cam lobes. The oil pan was removed to inspect the parts in the lower end of the engine for wear. Through the opening created by removing the oil pan it was possible to access some of the crankshaft journal bearings, which were removed for inspection. The tribofilm was visually identified on the crankshaft, bearings surfaces and cam lobes.

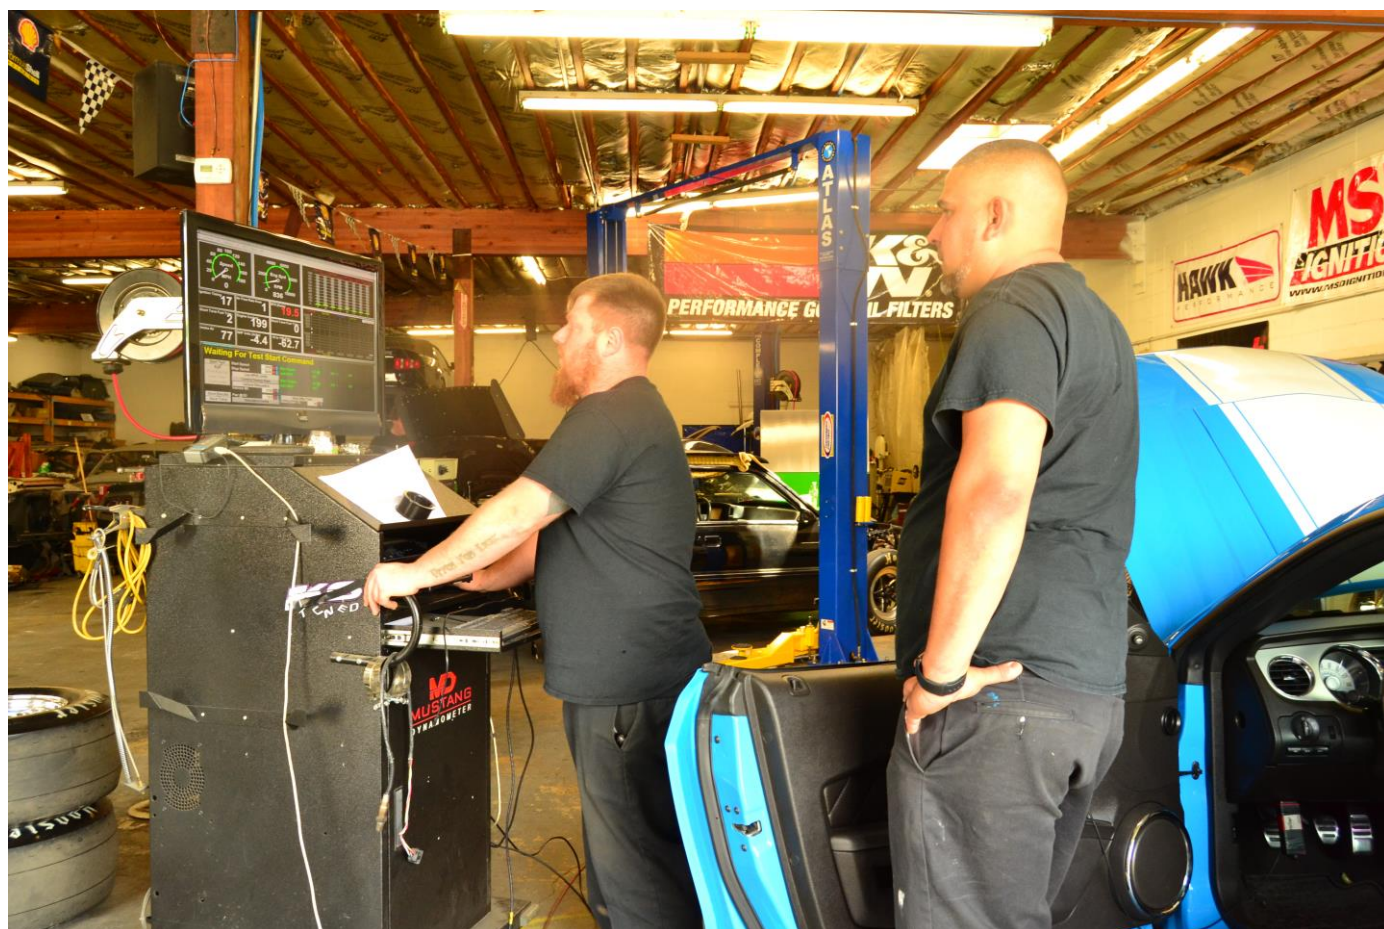
Figure 4. Data collection from a chassis dynamometer at The Mustang Shop (TMS) in Kent, WA. Light blue test vehicle can be in the bottom right of the photo.

The effects of TriboTEX engine coating on improvements in vehicle torque and power were measured by The Mustang Shop (Kent, Washington) on their in-house full vehicle dynamometer. One of the available shop vehicles (2015 Ford Mustang) was used in the test. To measure changes in torque and power the vehicle was tested on the dynamometer prior to TriboTEX treatment. After recording the baseline metrics, the vehicle was treated with TriboTEX and driven for 500 miles under normal road conditions to ensure full dispersion of nanoparticles and adequate coating formation. After the interval of normal driving the dynamometer test was performed again.

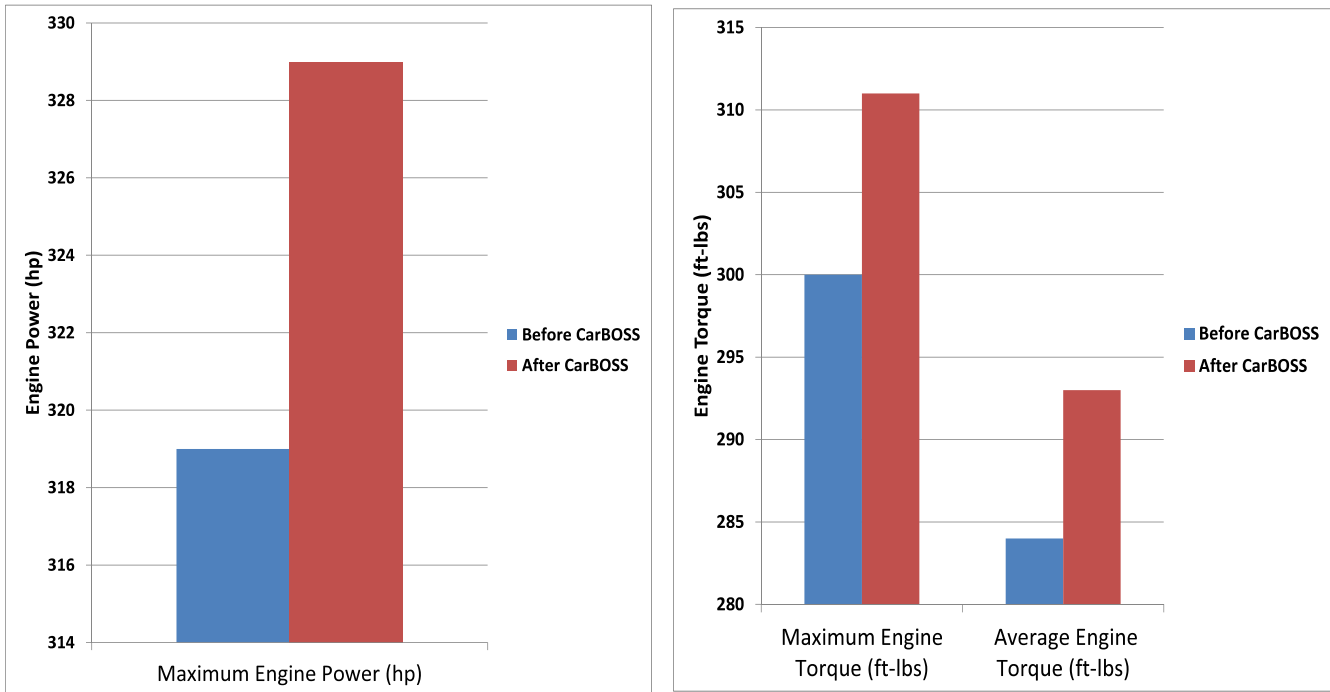
Figure 5. Third party dynamometer performance testing using a custom built 2015 Ford Mustang. Engine power (left) was recorded to increase from 319hp to 329hp. Torque also increased from 300ft-lbs to 311ft-lbs for maximum torque and 284ft-lbs to 293ft-lbs for average torque.

The baseline dynamometer measurements recorded the peak engine power at 319 hp and maximum torque at 300 ft-lbs. Average torque was calculated at 284 ft-lbs as a baseline. After being treated with TribotEX and undergoing 500 miles of driving under normal conditions the dynamometer tests indicated an increase in both power and torque. **Maximum engine power increased by 10 hp**, from 319 hp to 329 hp (+3.1%). **Average torque and peak torque increased** to 311 ft-lbs (+3.7%) and 293 ft-lbs (3.2%), respectfully.

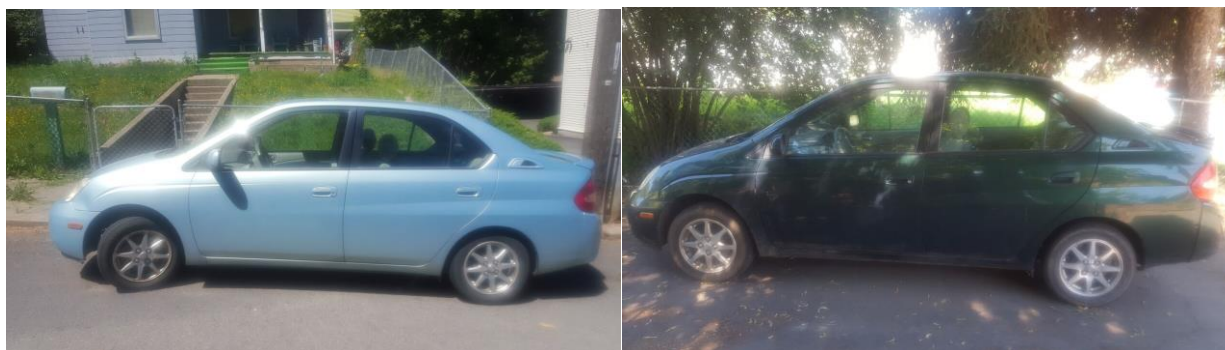
Figure 7. Two 1st generation Toyota Prius test vehicles: blue baseline vehicle (left), odometer reading 160k miles, and the green vehicle with one application to the engine oil compartment of TriboTEX nanomaterial engine coating (right), odometer reading 203k miles.

Two 1st generation Toyota Prius vehicles (1.5L 4-cylinder Atkinson-cycle Engine with a CVT drivetrain) were used in head-to-head device testing comparisons to measure the effect of TriboTEX engine coatings on hybrid vehicle fuel economy under different road conditions. The differentiating factors between the vehicles were: color, mileage, and an application TriboTEX nanomaterial engine coatings. At the time of testing, the baseline vehicle (blue) and the vehicle with TriboTEX engine coatings (green) had odometer readings of 160k miles and 203k miles, respectively.

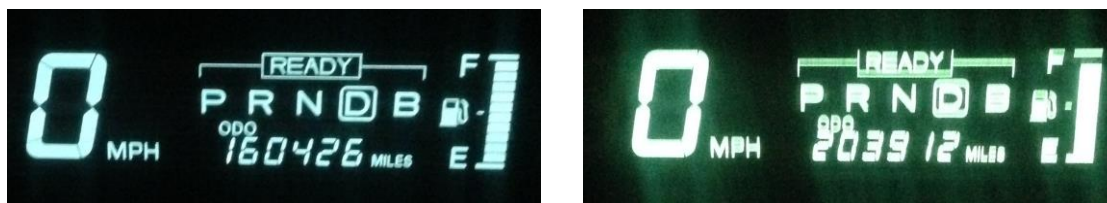
Figure 8. Photograph of vehicle odometer readings. The blue baseline Prius is pictured on the left. The green Prius with TriboTEX engine coating is pictured on the right.

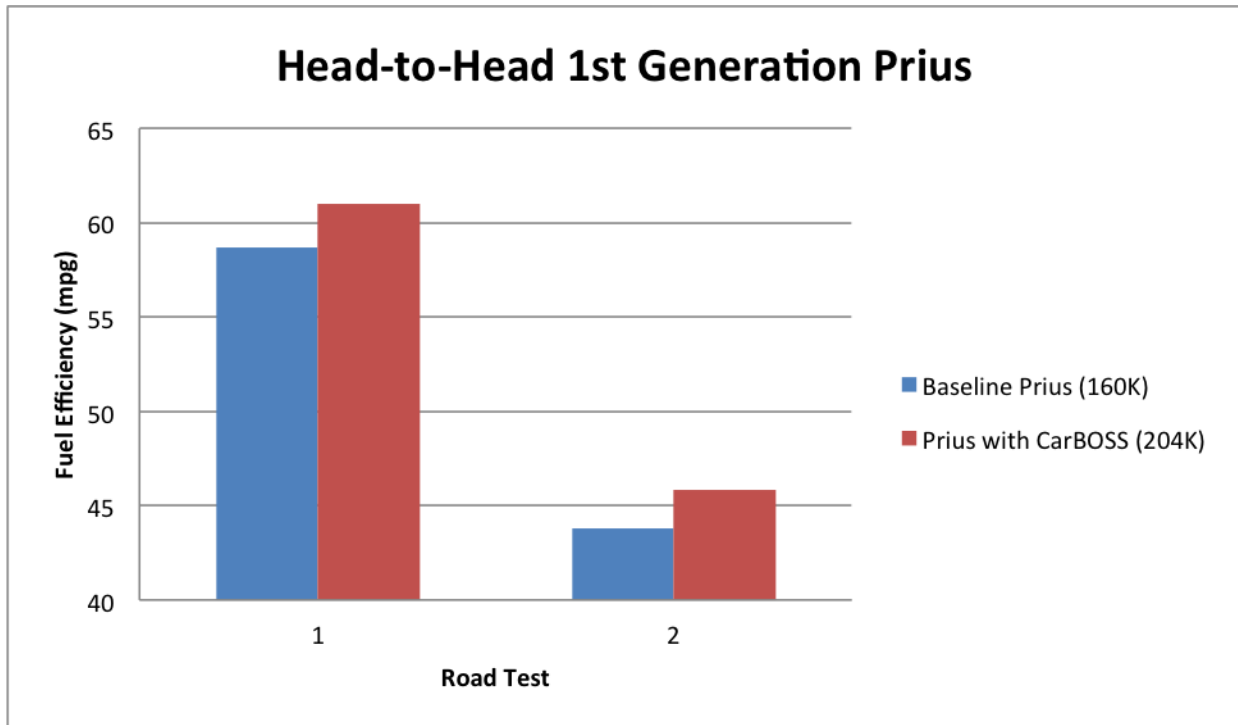
Figure 10. Results from preliminary testing on Almota Road. The blue bars represent the fuel efficiency measured in the baseline vehicle (blue Prius with 160K) for both the forward (Road Test 1) and the return (Road Test 2) trip. The red bars represent the fuel efficiency in the vehicle with added nanomaterial engine coating provided by TribotEX (green Prius with 204K) for both the forward (Road Test 1) and the return (Road Test 2) trip.

The difference between the forward and backward routes however was substantial, due to a large change in elevation (from 2339.5 feet to 1983.6 feet). A significant difference in fuel efficiency (~25%) was observed between the two test routes, for both vehicles (See Figure 9). However, on both routes **the higher mileage Prius, treated with one application of the TribotEX engine coating, proved to have approximately 4% higher fuel efficiency than the baseline vehicle with fewer odometer miles.**
