General Service Bulletin (GSB):	Engine Failure Analysis and Tips
GSB Overview:	This bulletin provides tips to assist the dealership when performing engine diagnostics and root cause determination.
NOTE: This information is not intended to replace or supersede any warranty, parts and service policy, Work Shop Manual (WSM) procedures, PC/ED procedures or technical training or wiring diagram information.

# **Engine Failure Analysis and Tips Job Aid**

Guide to Engine Analysis and Preventing Repeat Engine Failures

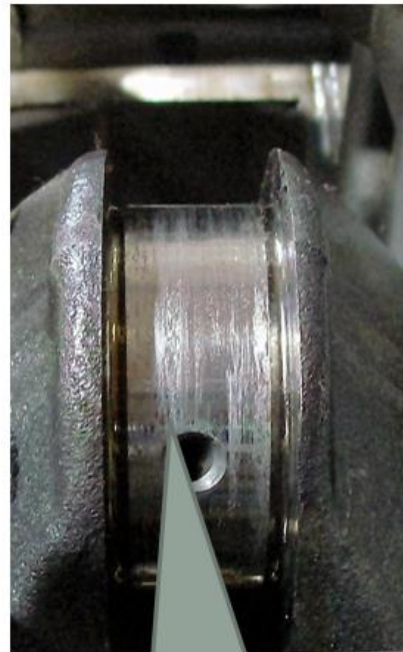
Deep Scratches

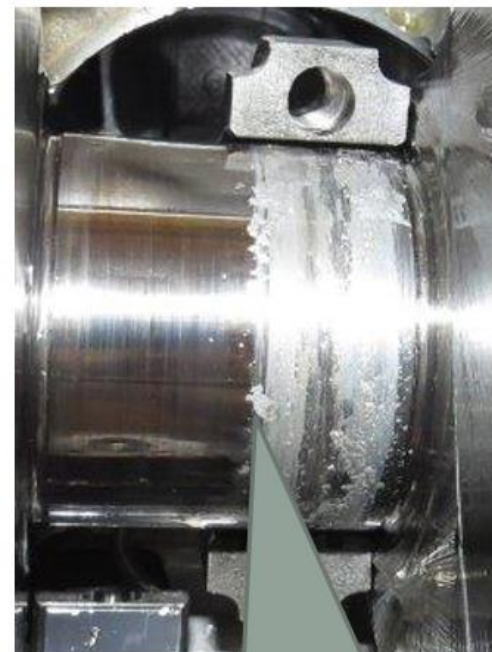
Bearing Metal Transfer

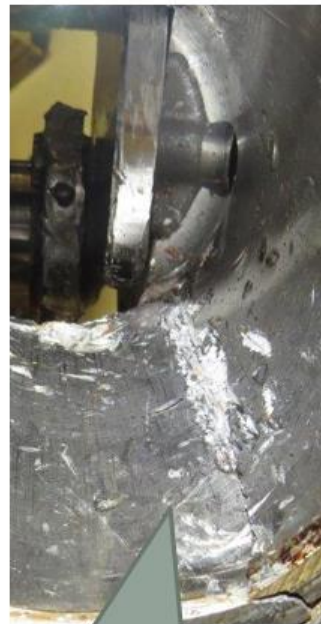
Impact marks

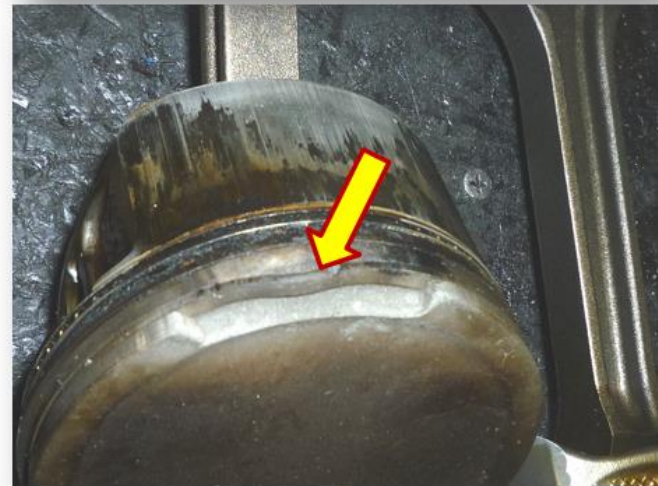
1. Spark plug damage (porcelain fractured or electrode melted off) is an indication of excessive detonation.
2. Heat generated from friction caused cylinder wall to crack (note upper ring land damage).
3. Excessive levels of detonation cause excessive cylinder pressure spikes leading to piston ring land fractures. In this instance, the less obvious second ring land is damaged.

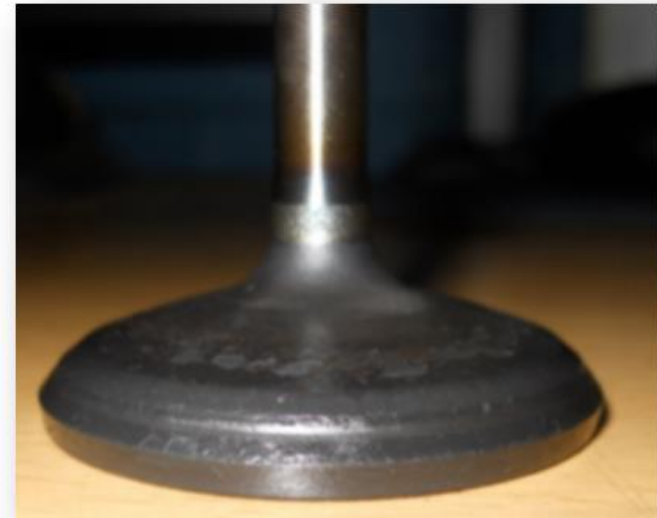
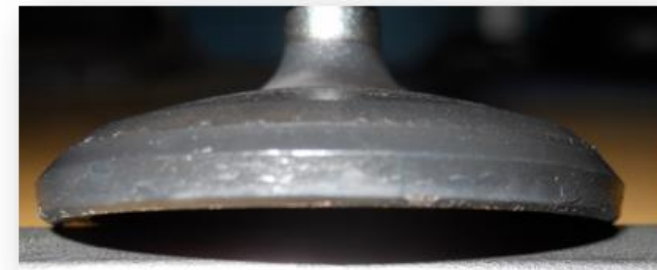
Excessively lean conditions can cause valves to overheat. As an overheated, softened valve opens and closes on the valve seat, it will deform. The valve will no longer seal on the valve seat as it stretches or “tulips” causing leakage and a misfire.

**Remember:** Valve tuliping is the effect, not root cause of the concern.

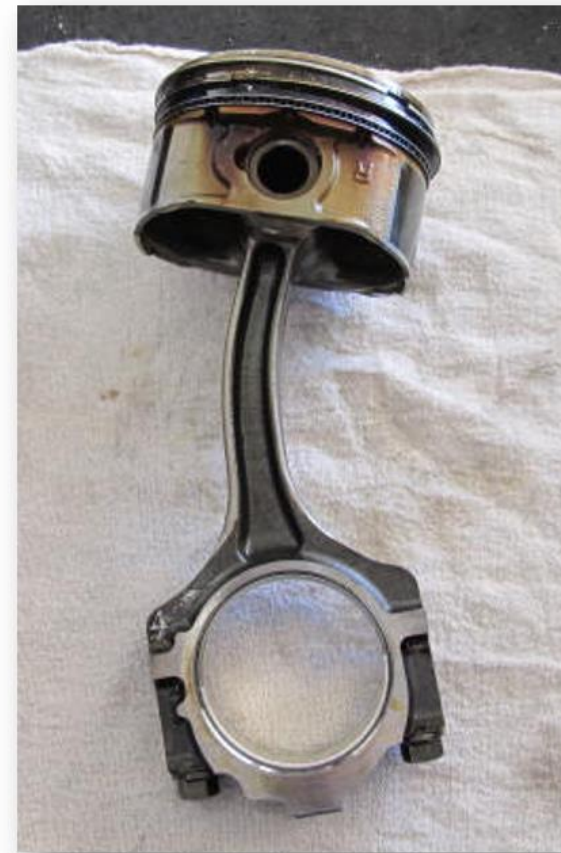
Since fluids cannot be compressed, the connecting rod typically suffers from a hydrolock event.
